Impact Floor Solutions, Inc. -Citizen Center Concord May 2013-

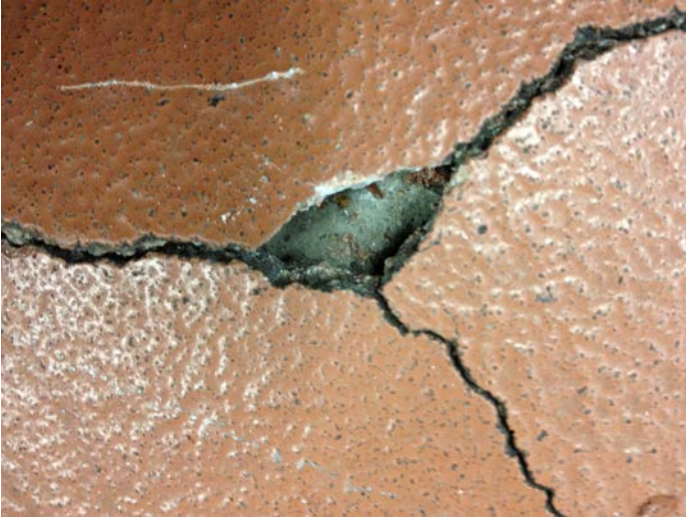
Moisture & improper installation caused dis-bonding

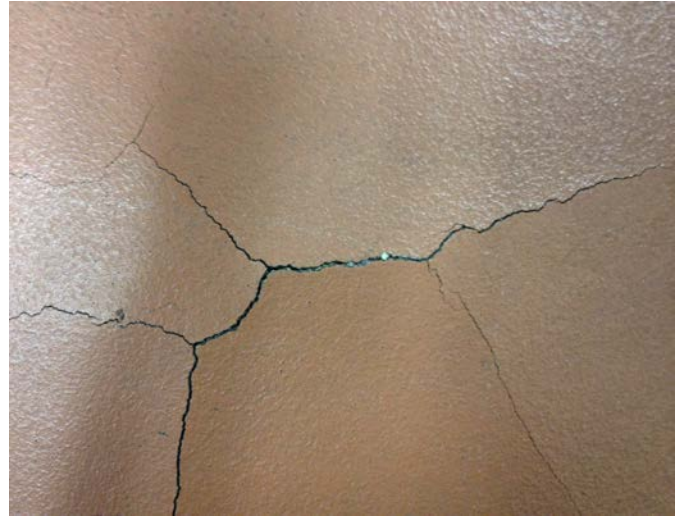
Several areas showed complete floor system 'bulging'
