## -3,200 sq.ft. Automotive Detail Shop, San Francisco, April 2015-

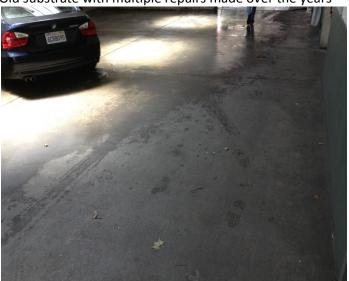
Old substrate with multiple repairs made over the years

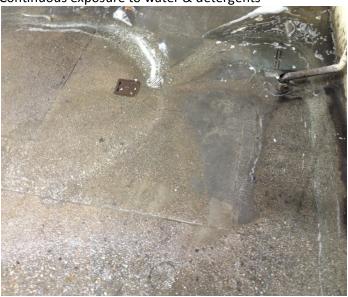
Continuous exposure to water & detergents

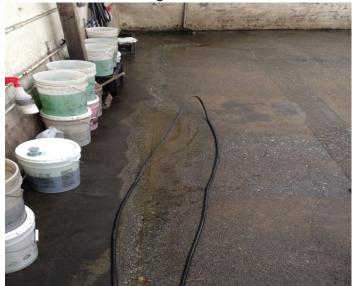
Areas shown with standing water

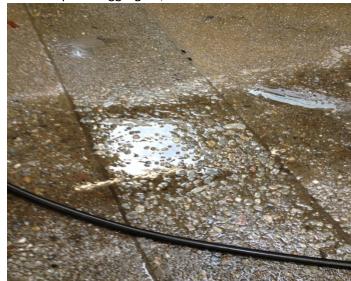
Lots of exposed aggregate, saturated with moisture

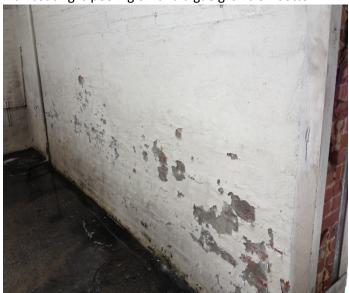
Wall coating is peeling off and algae grows on bottom
