Flake system outdoor balcony & stairs Oakland H.O.A. -July 2014-

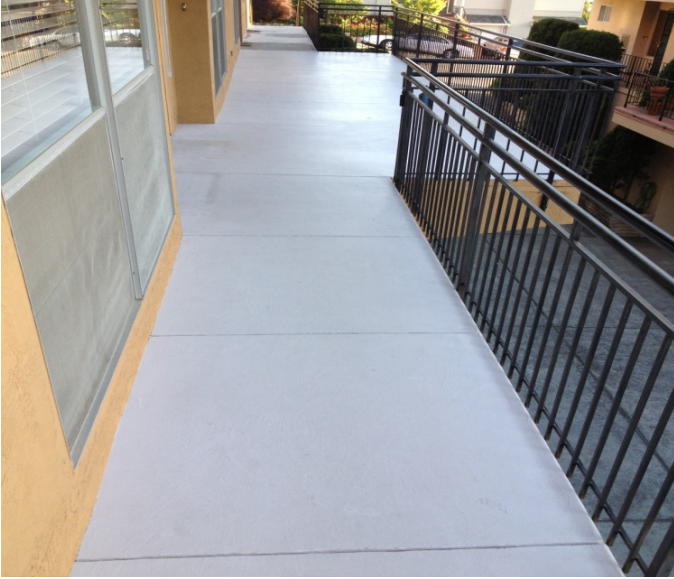
Current concrete with paint (failing & chipping)

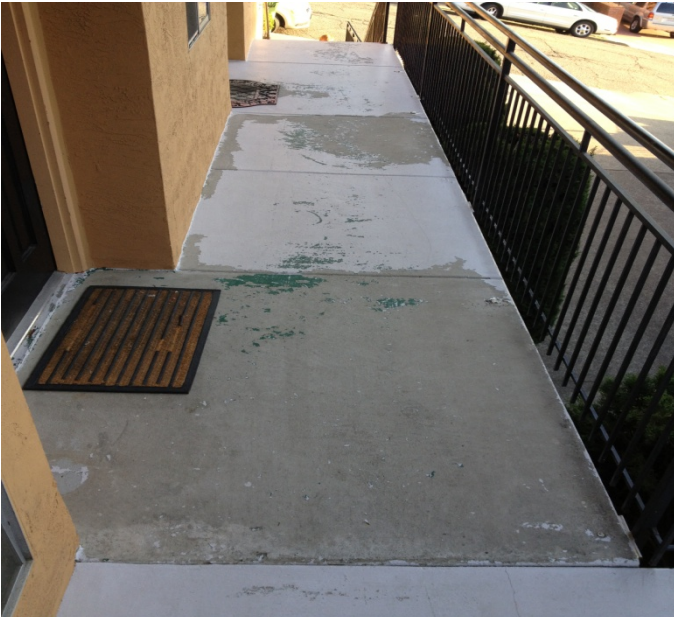
Damaged area
