-Apartment Complex Lobby, Walnut Creek, September 2014

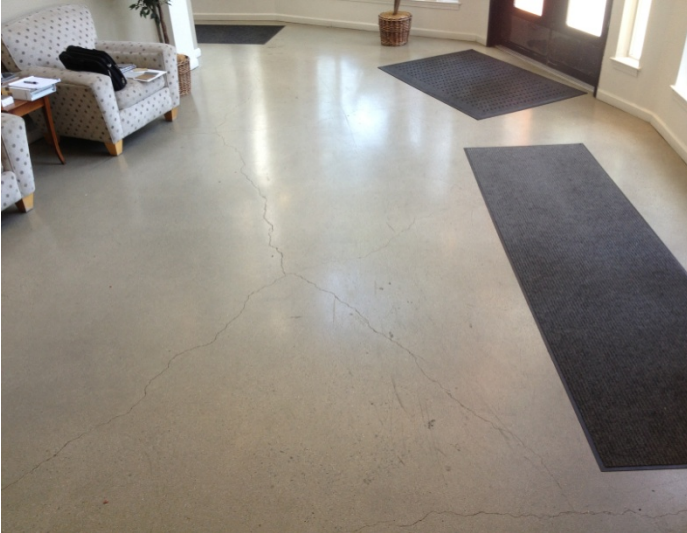
Old substrate with cracks and divots that fill with dirt

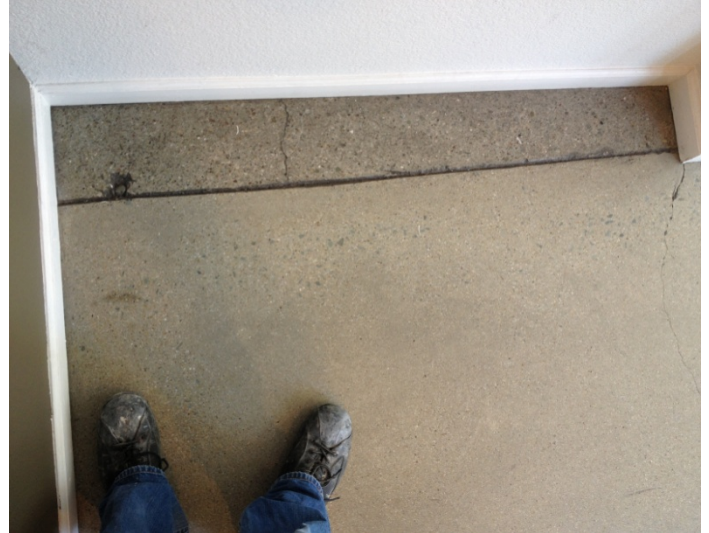
Excessive substrate movement causes low spots

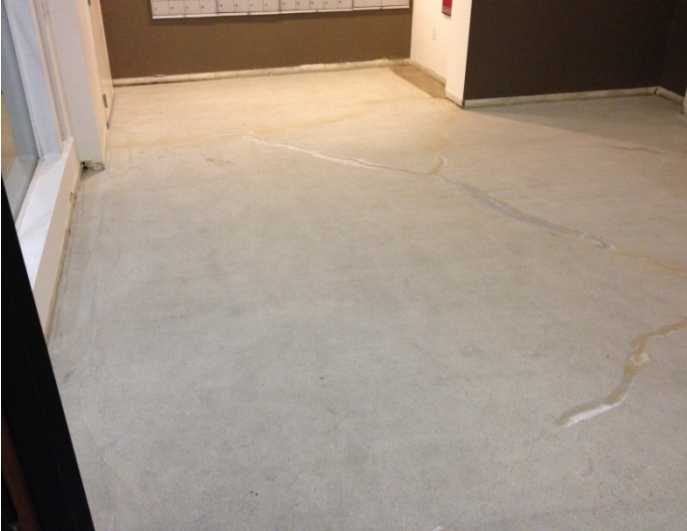
Whole area diamond grinded, cracks opened & patched

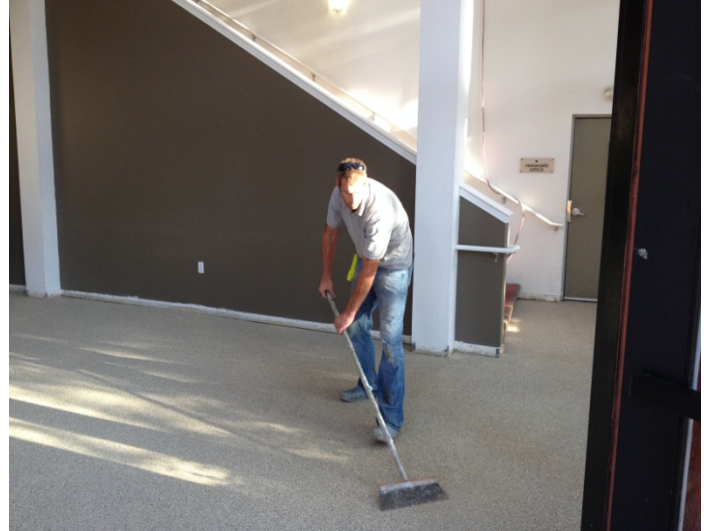
Scraping of vinyl flakes to remove sharp edges

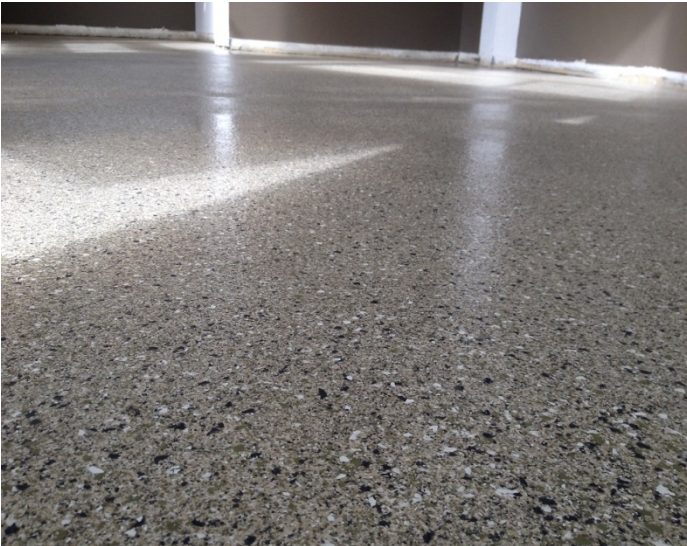
Close up of Camouflage Hybrid Flakes, nice & smooth

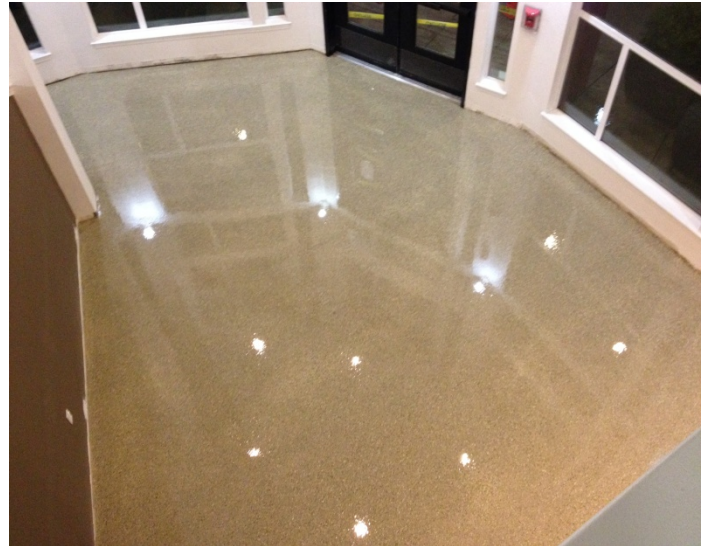
Water clear topcoat with full gloss when just installed
