- Impact Floor Solutions, Inc.-

dba Polymer Floor & Wall Coating Systems

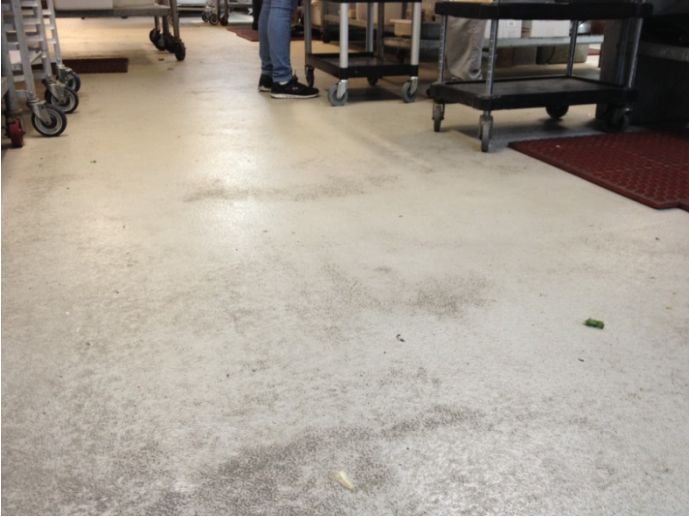
Worn out epoxy with pinhole cavities & rough texture

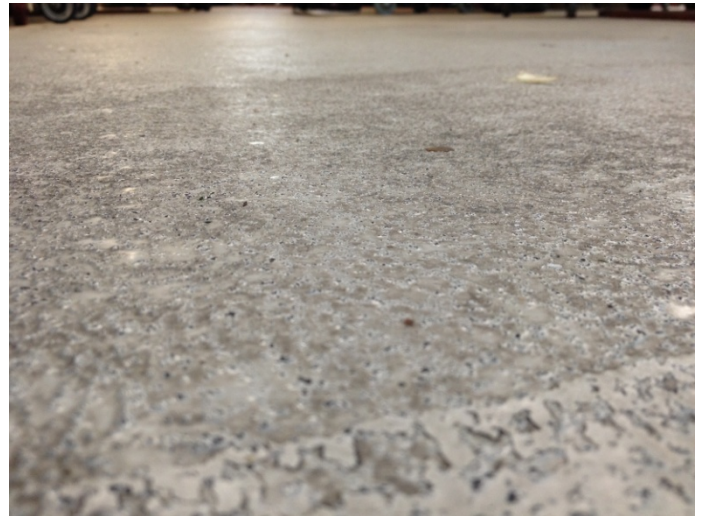
Exposed aggregate, makes it hard to clean & porous
