Impact Floor Solutions, Inc. -Project Henkel Corporation, November 2013-

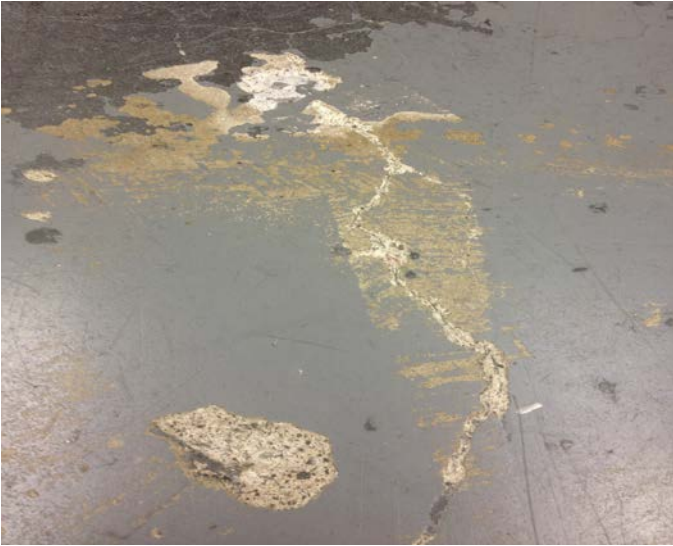
Before

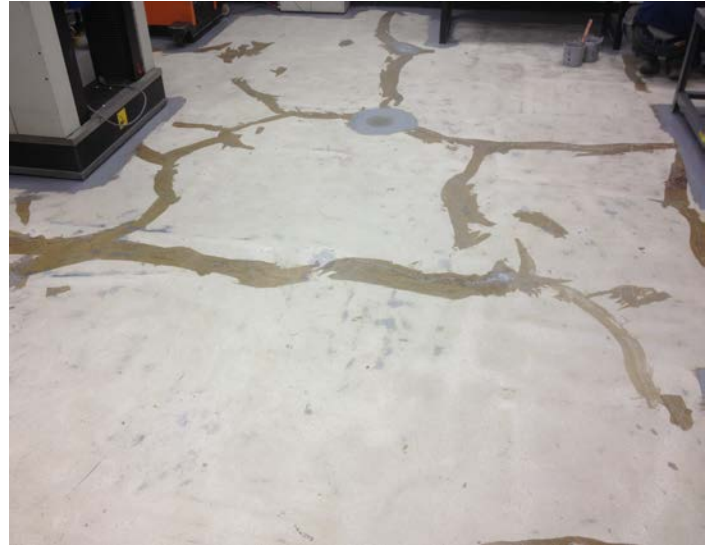
After removal old coating, profiling and crack repair

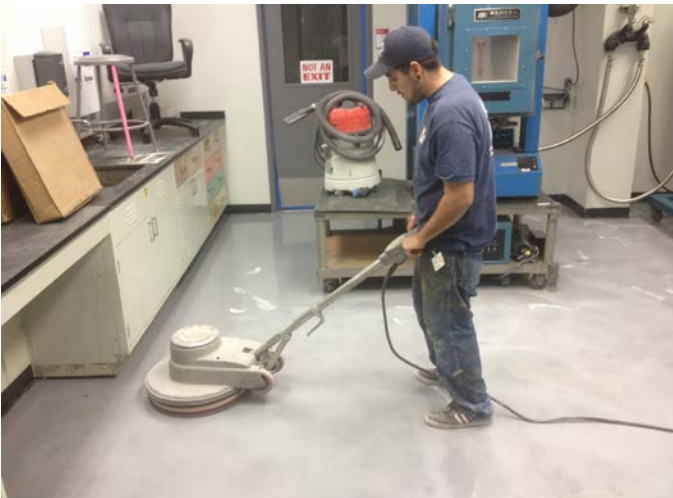
Sand screening with 80-grit after priming & more patching

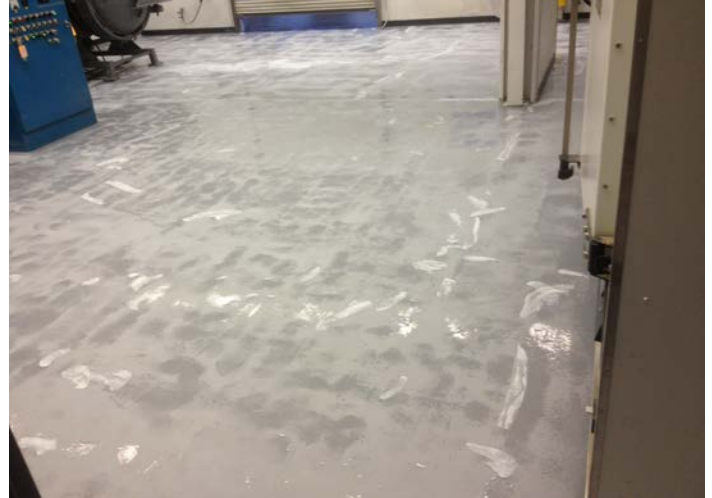
Ready for top coat

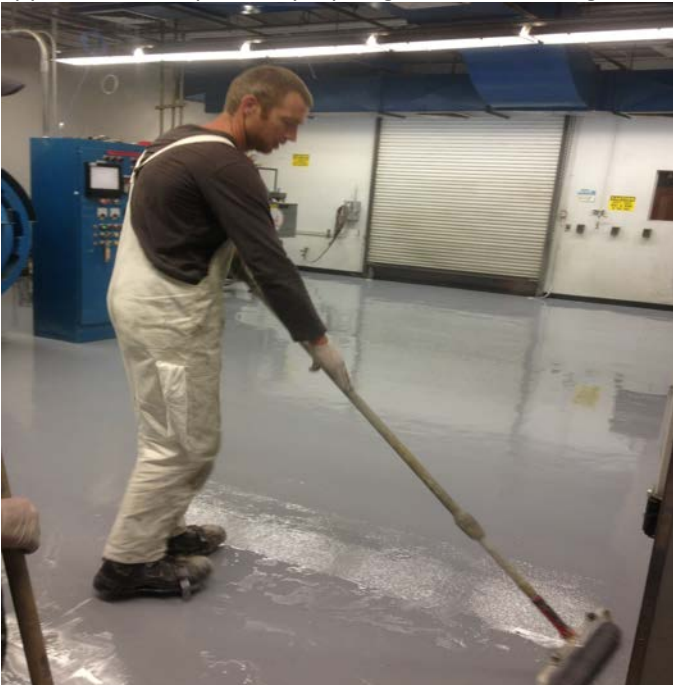
Application of top coat by squeegee & back-rolling

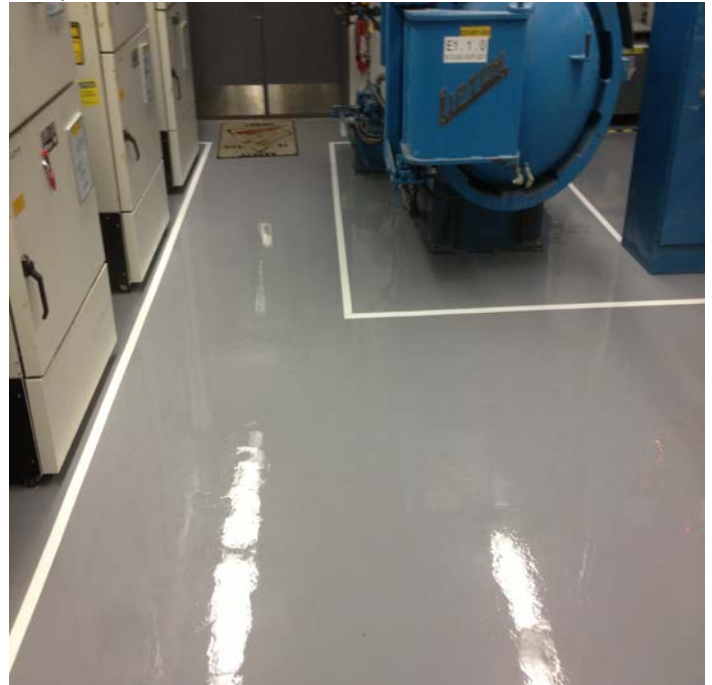
Completed
