# -Showroom concrete polishing 'Hertz Equipment Rental', Oakland, August 2015-

## - Impact Floor Solutions, Inc.-

Polymer Floor & Wall Coating Systems

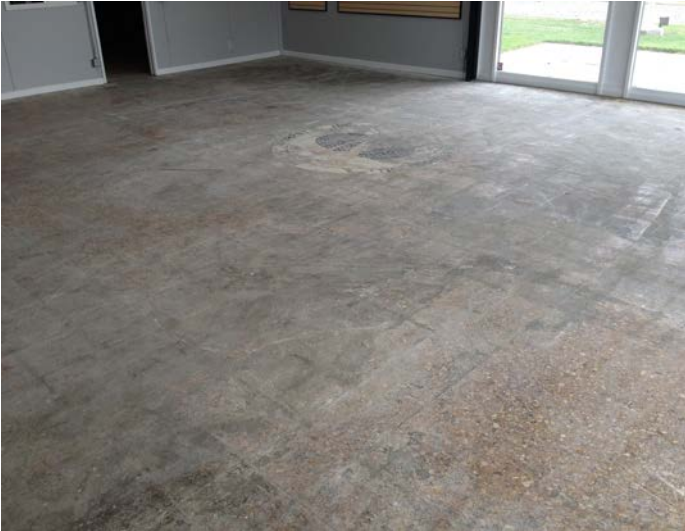
Vinyl composite tile removed, found original terrazzo covered with multiple layers of glue, mastic & sealers

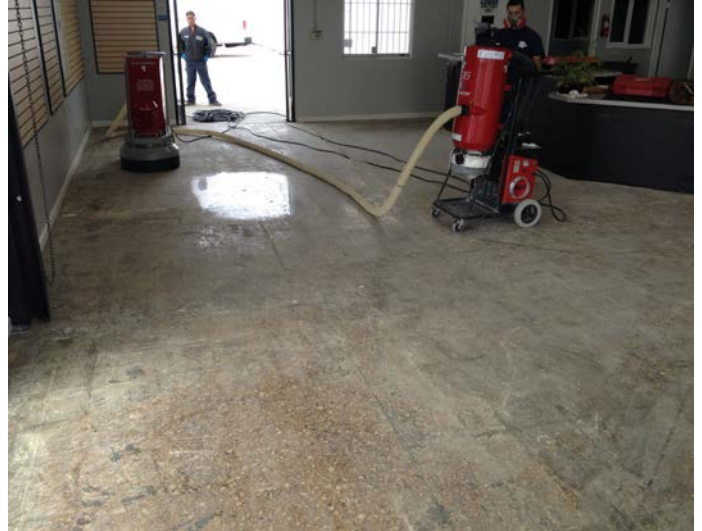
Some areas had 1/4" thick glue that had to be removed

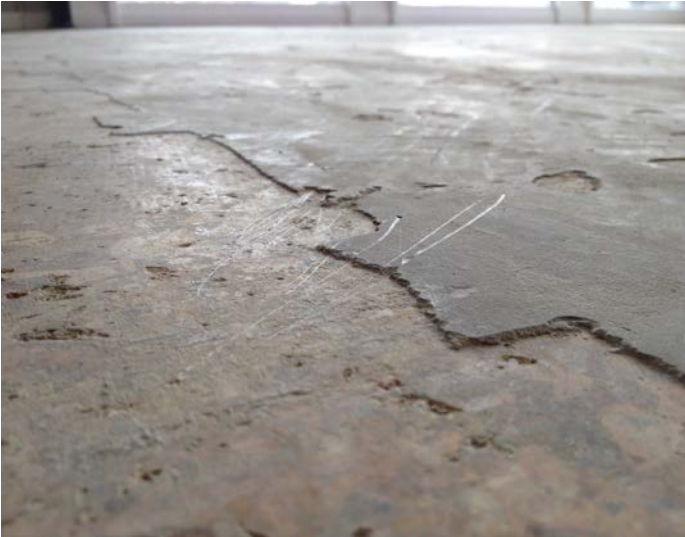
First passes with more aggressive 50-grit metal diamonds

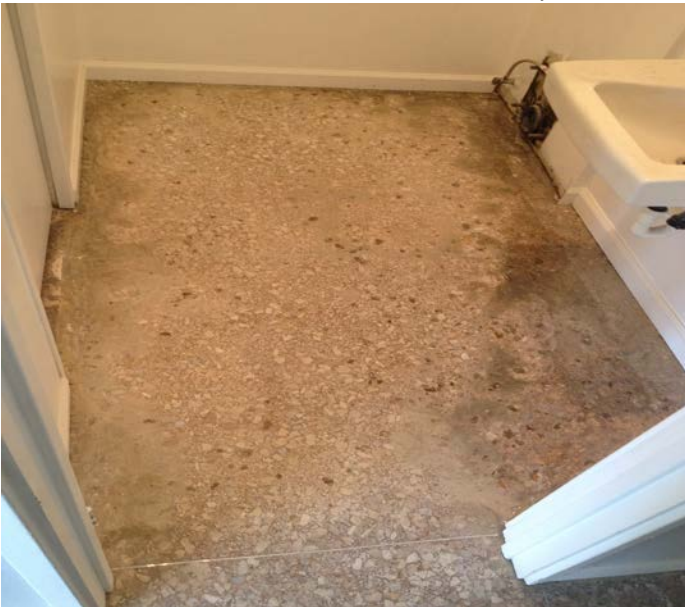
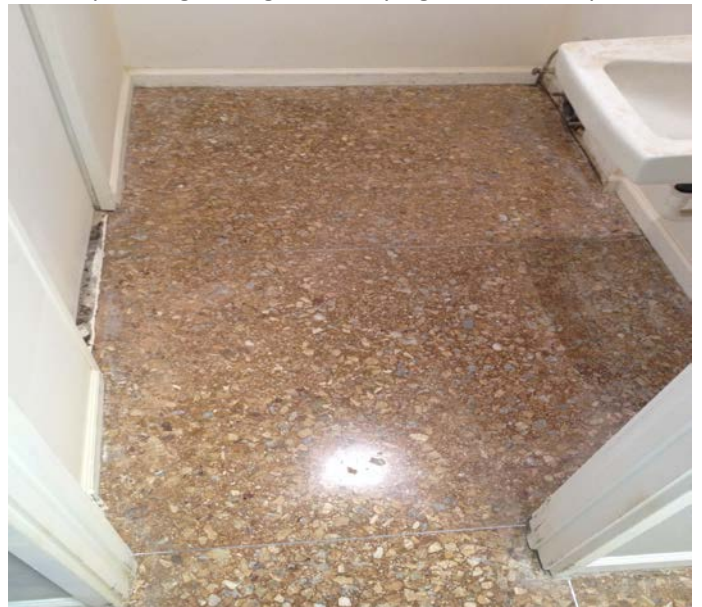
After 7 passes grinding & densifying, before final polish

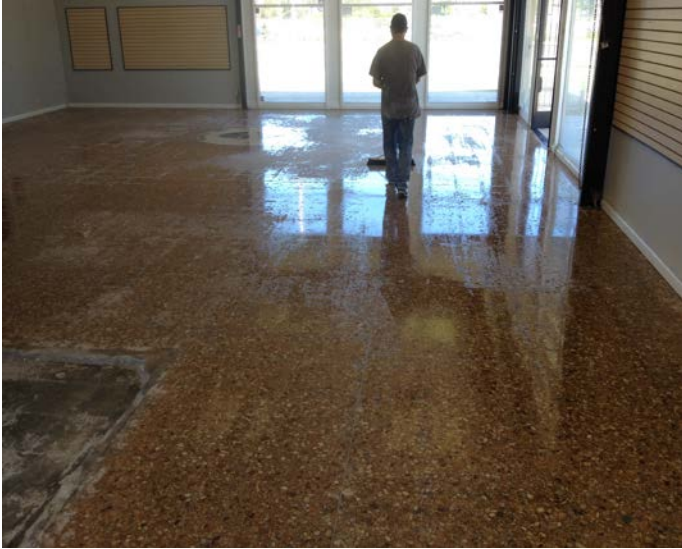
Preparation for densifying to increase substrate strength

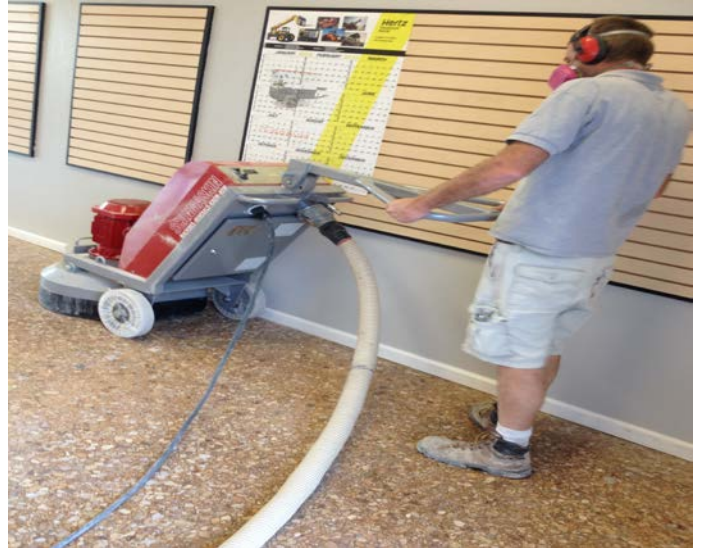
Another pass of 400 grit resin pads, already starts to shine

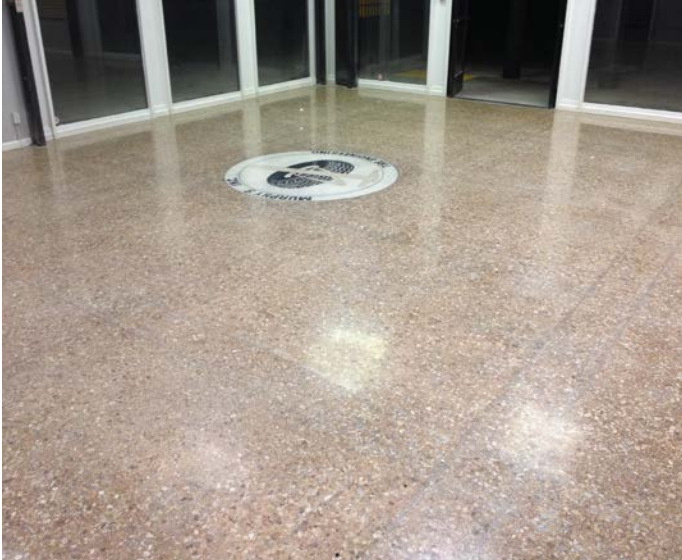
After 12 passes, 9 different grinding pads

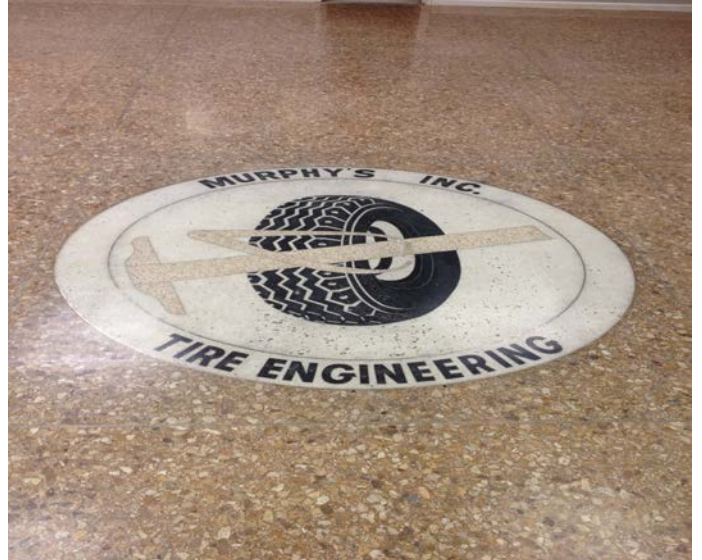
Very cool logo that was hidden, came back to life

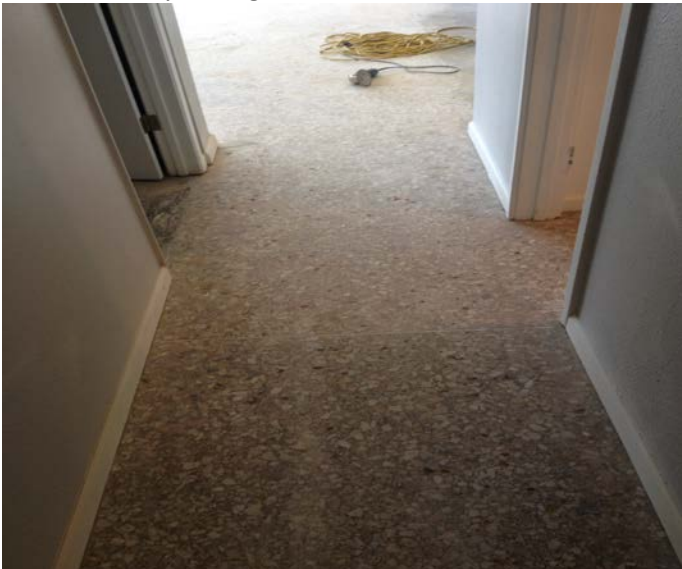
Restroom alley after glue removal

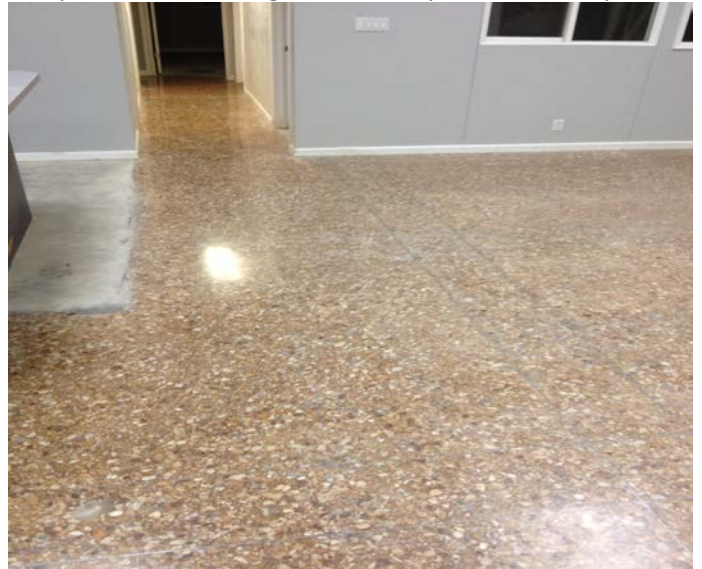
Completed with 1200 grit finish, all polished & easy to clean
