# -Laundromat, Los Angeles, September 2012-

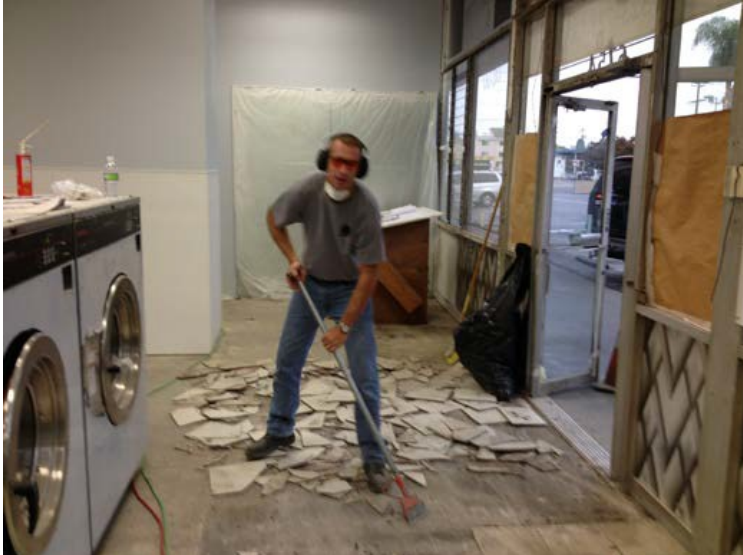
All tile at entryway to be removed prior to concrete profiling

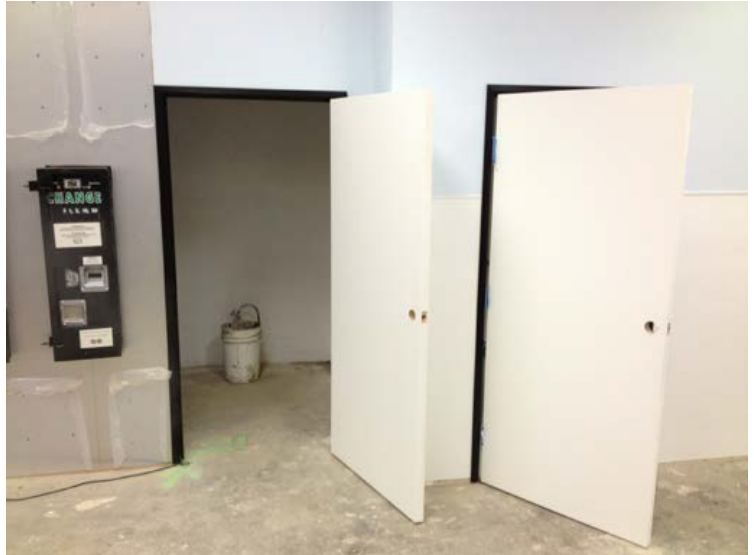
Dirty substrate with lots of imperfections

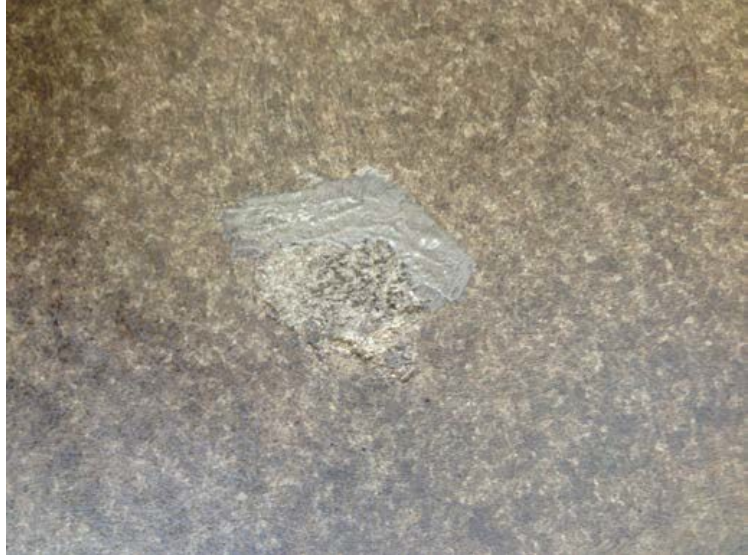
Fresh patch before smoothing and colorant to be added
