-Mariposa Baking Company, Oakland, March 2017-

- Impact Floor Solutions, Inc.-

dba Polymer Floor & Wall Coating Systems

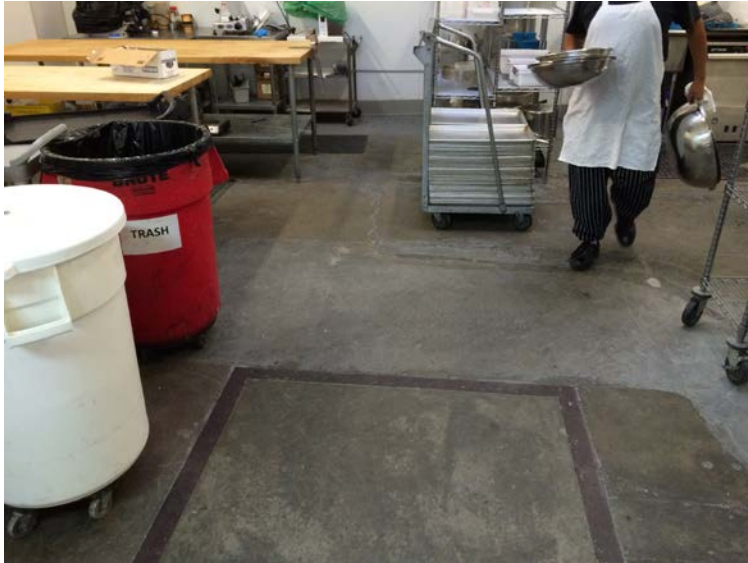
Bare concrete substrate where all epoxy has come off over time

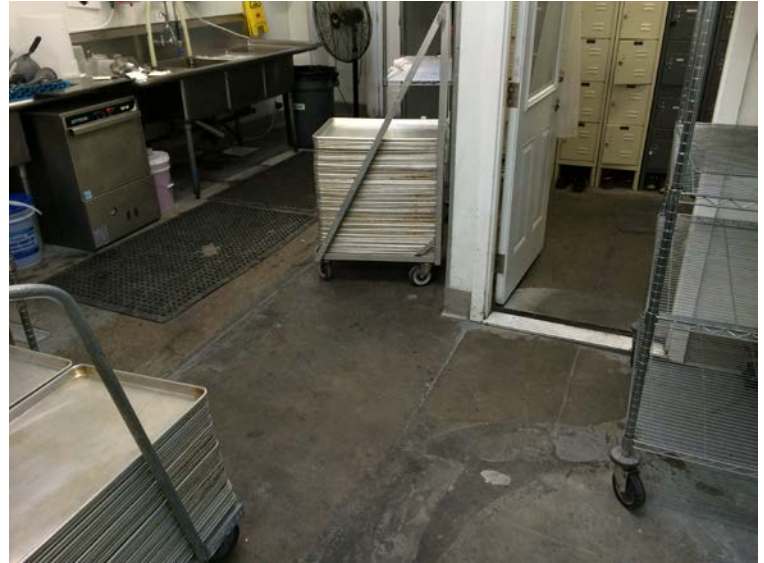
Slippery and hard to clean exposed concrete; a sanitary nightmare

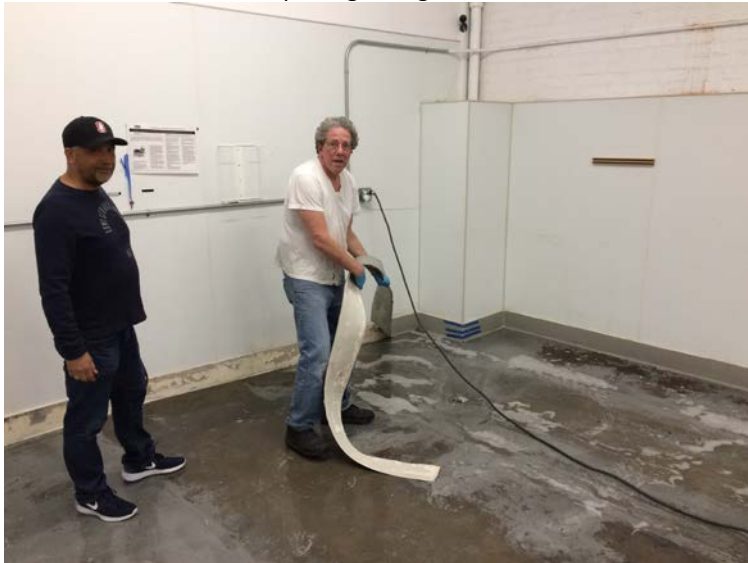
Adhesive backed cove strip has got to go as well
