-Martinez Juvenile Hall, August 2013-

- Impact Floor Solutions, Inc.-
Polymer Floor & Wall Coating Systems

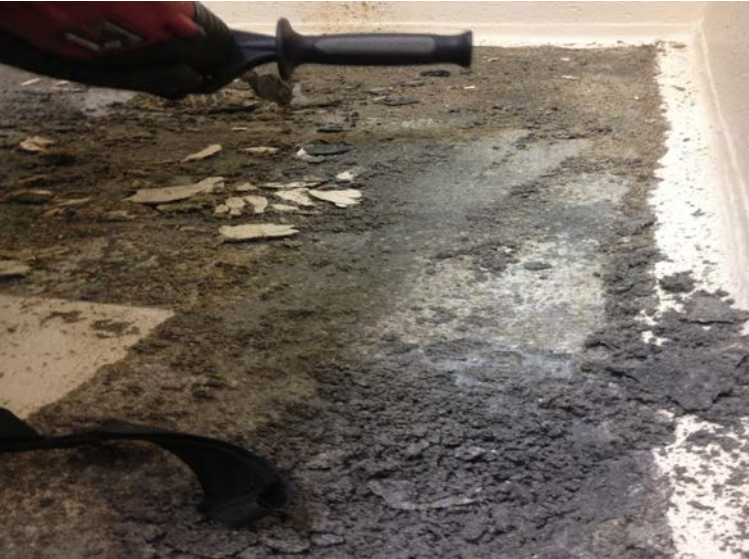
Existing coating had too much sand and was completely deteriorated & saturated. Removal with chipping hammer of all 6 shower stalls

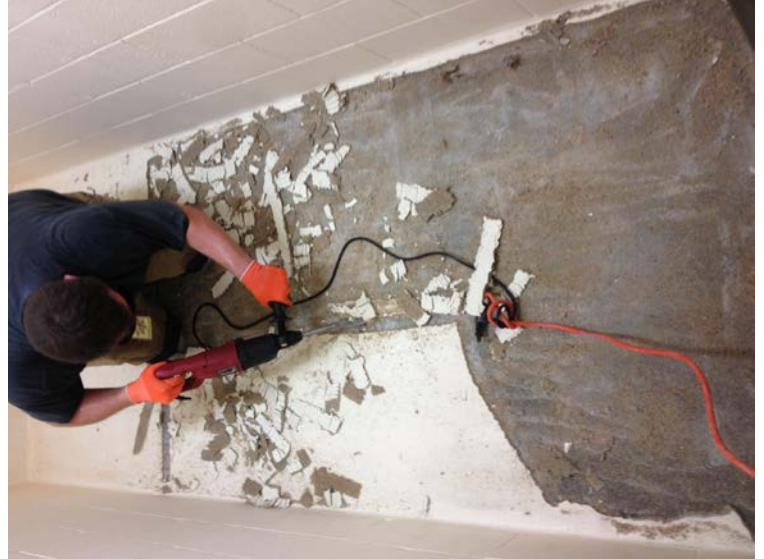
Plumbing fixtures leaks & saturation made for additional challenges
