# -The Ritz-Carlton (Employee Showers), March 2017-

**- Impact Floor Solutions, Inc.-**  
dba Polymer Floor & Wall Coating Systems

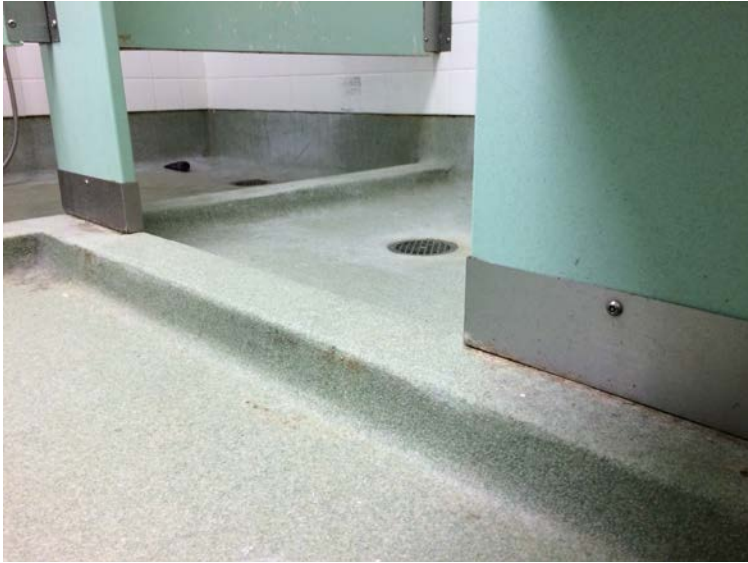
Existing epoxy Quartz floor hard to keep clean; too rough texture.
