# Impact Floor Solutions, Inc. -Project Trinity Lutheran Church Jan. 2014-

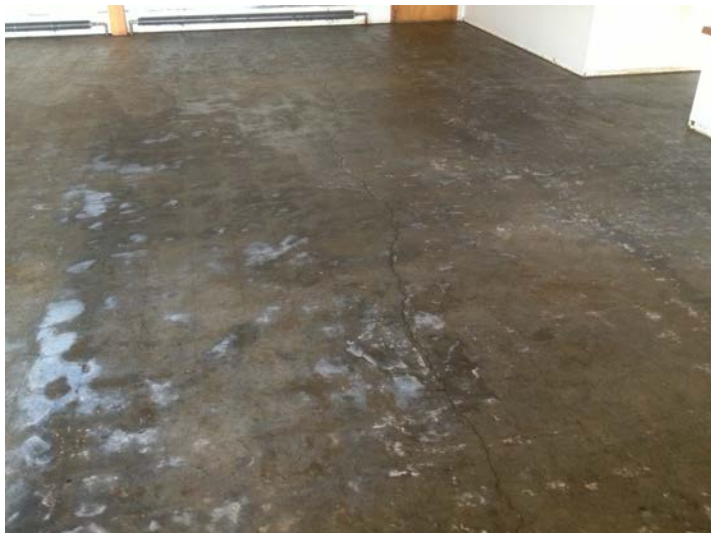
Before

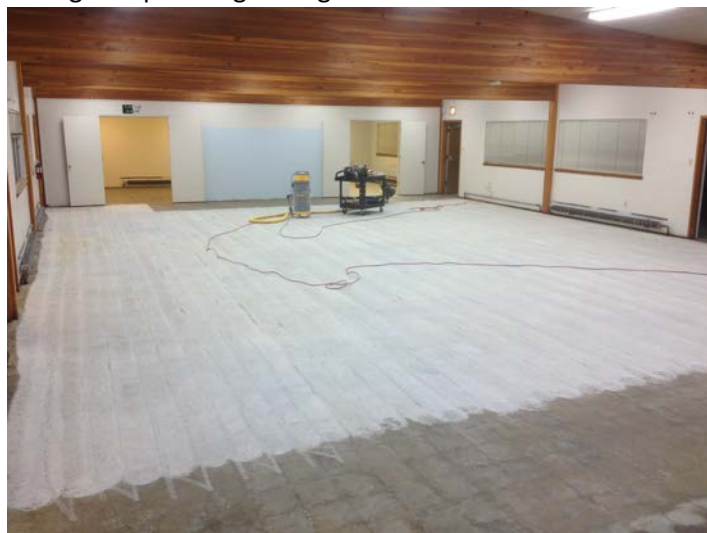
During first pass of grinding

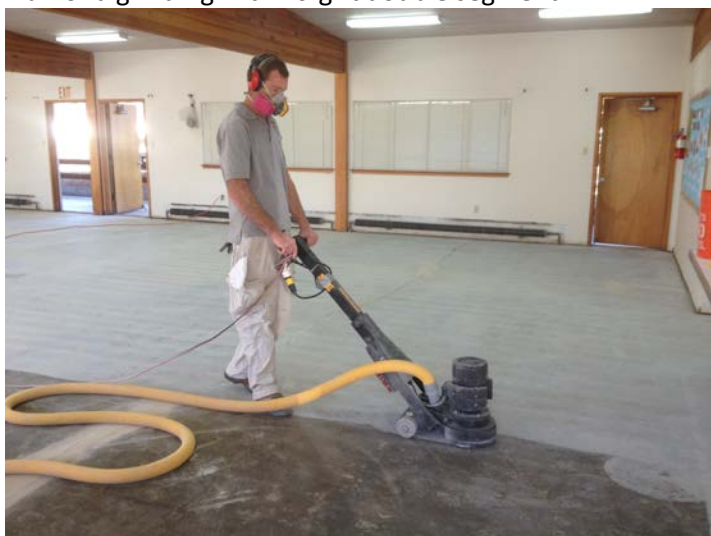
Diamond grinding with 16-grit double segment

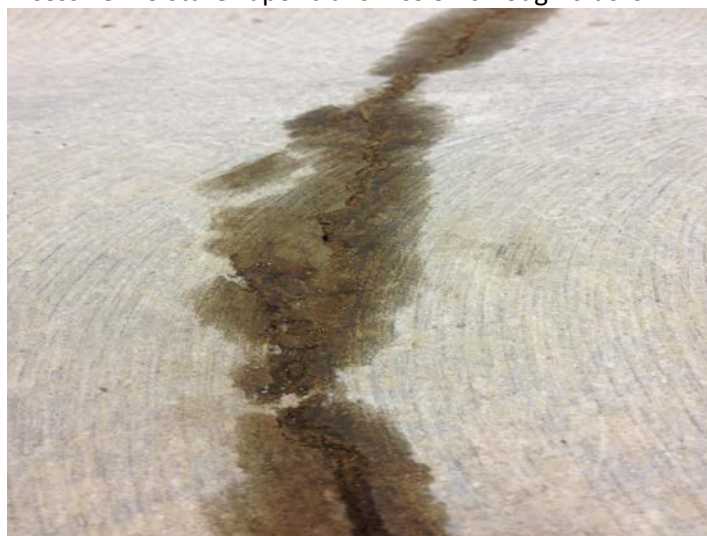
Excessive moisture vapor transmission through cracks

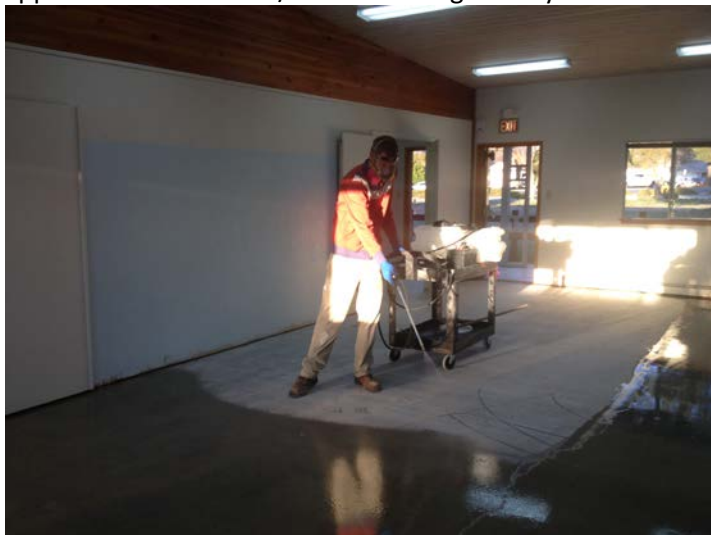
Application of densifier/moisture mitigation system

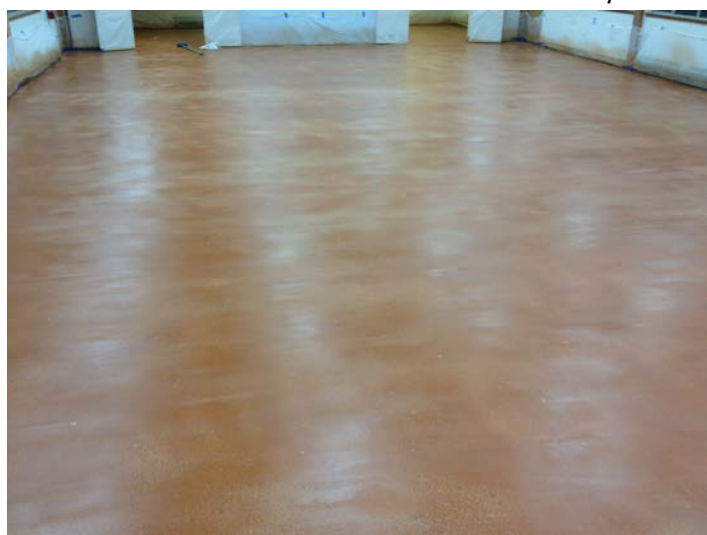
Base coat of Terra Cotta after cementitious overlay

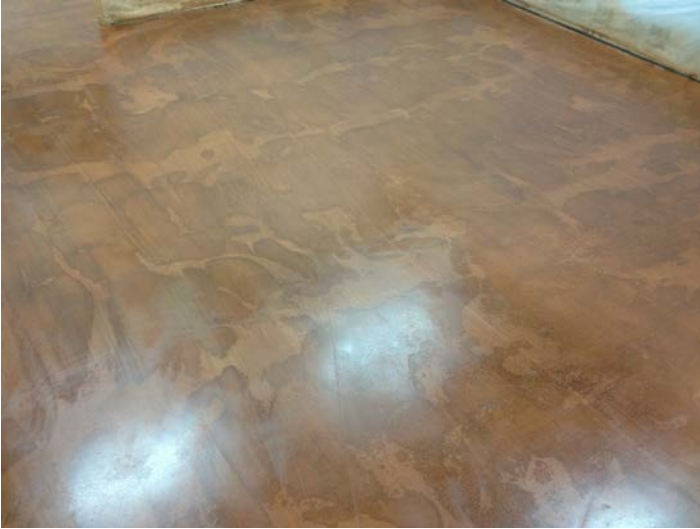
Walnut stain

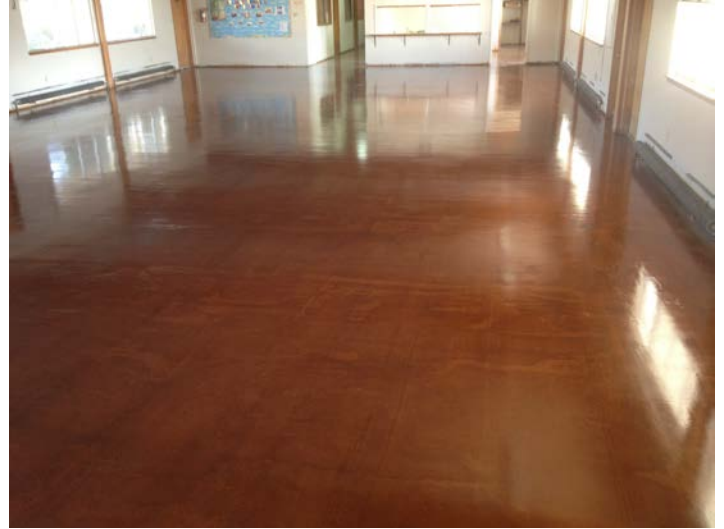
Project finished with sealer
