Impact Floor Solutions, Inc. -Solano County Jail, March 2014-

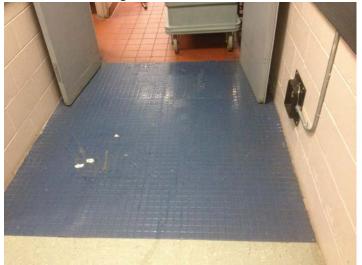
Before, delaminating rubber mats over saturated concrete

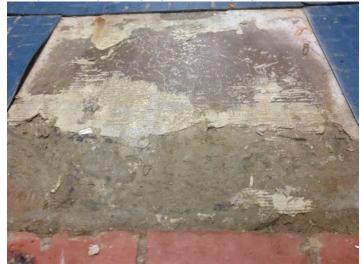
Multiple overlays & improper surface preparation

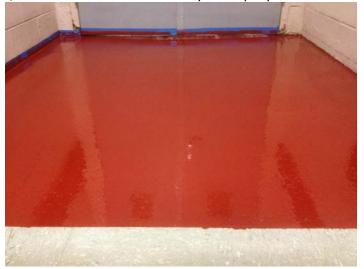
1/4" trowel down urethane slurry with epoxy seal coat

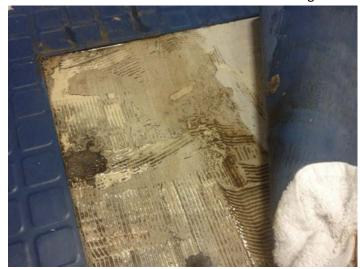
Adhesive looses bond because of moisture & food grease

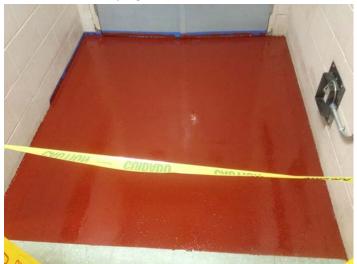
Removed all overlays, glues & cleaned with microbial
