Commercial Kitchen Floor, Cable Car City Pub & Cafe -February 2015-

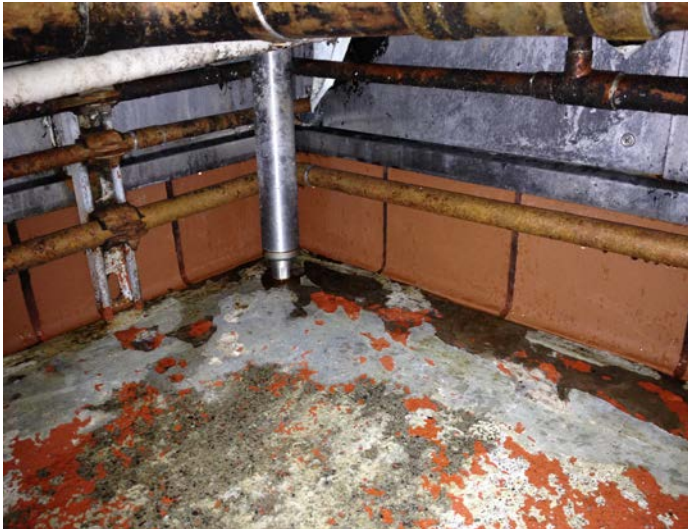
Old substrate with multiple repairs made over the years

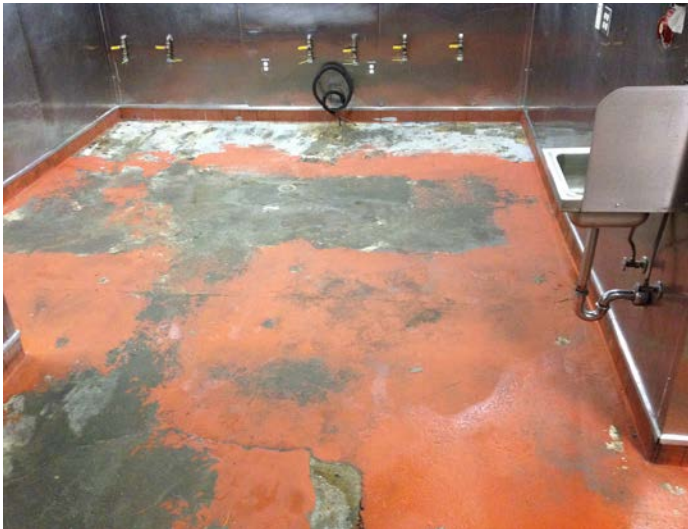
Grease and fats are coming off already

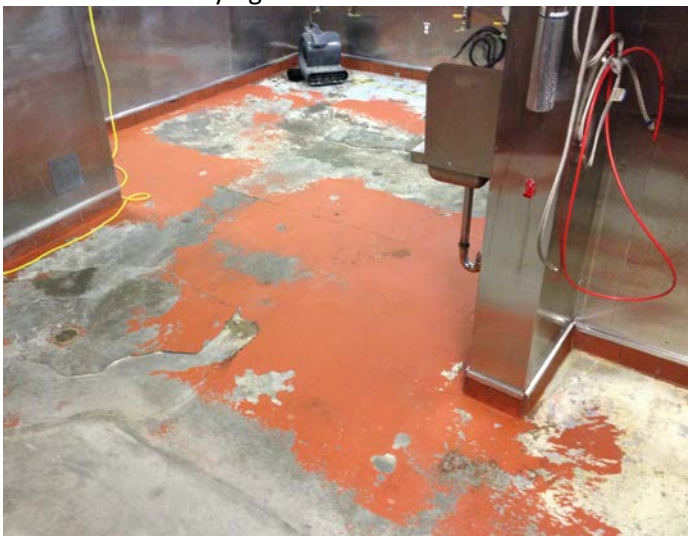
Substrate blow-drying after all contaminants removed

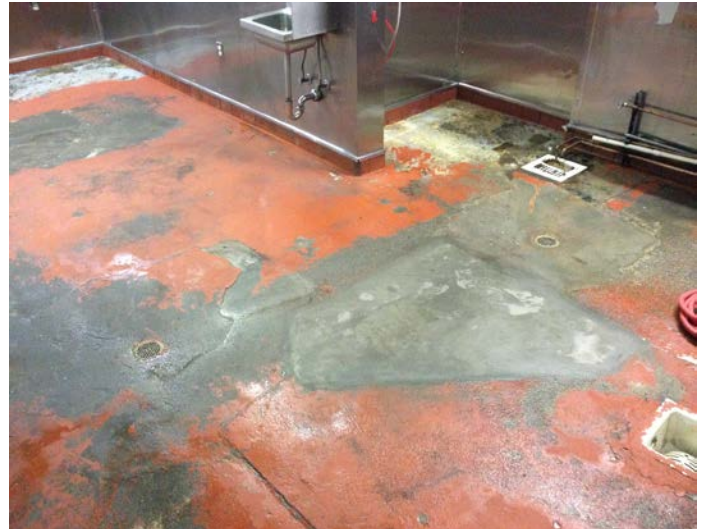
First cleaning with hot water & heavy duty cleaner

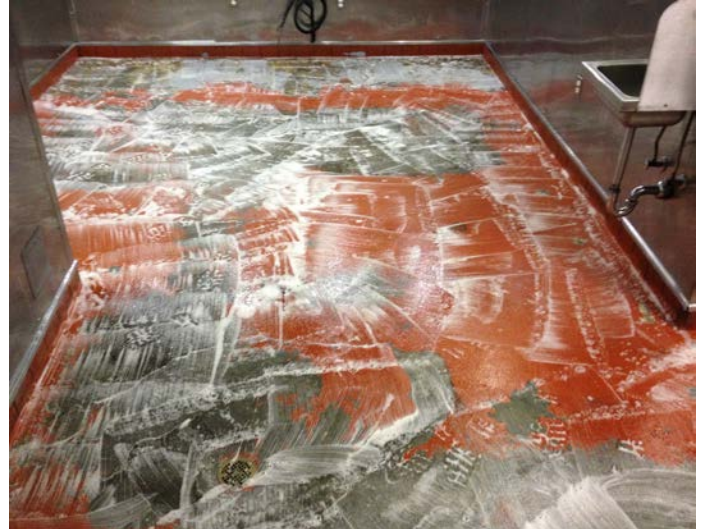
Then two passes with Industrial Microbial cleaner

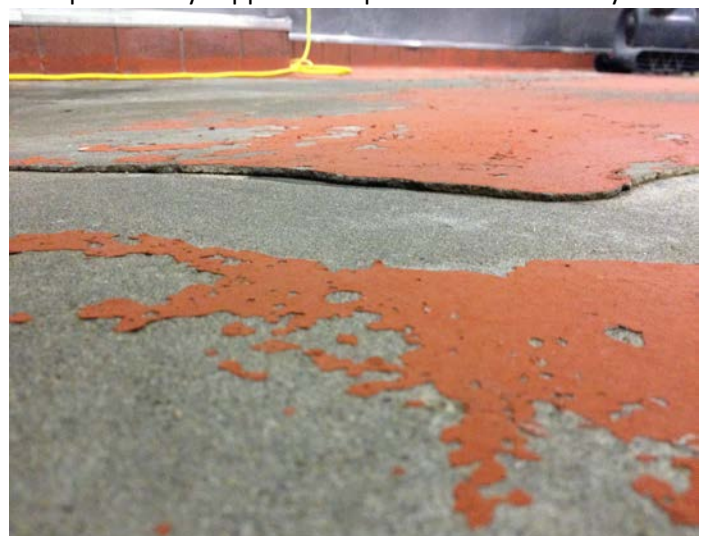
Multiple overlays applied & repairs made over the years

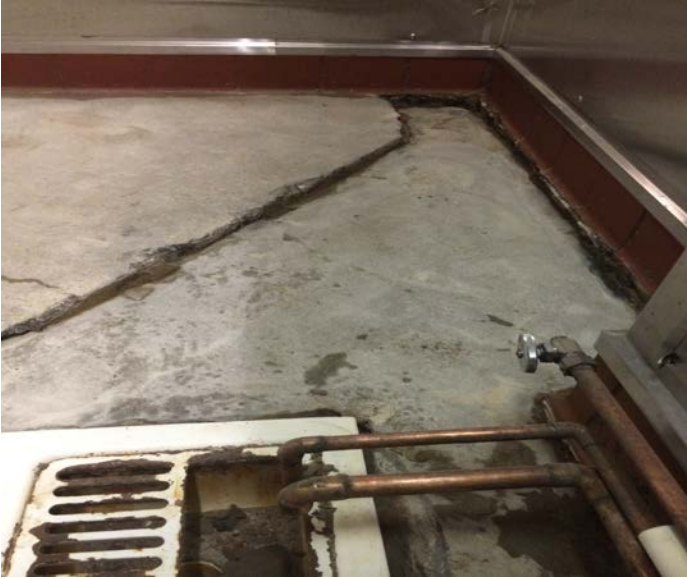
Whole area diamond grinded plus all repairs & overlays removed to prevent future failure. All HVAC masked w/ plastic

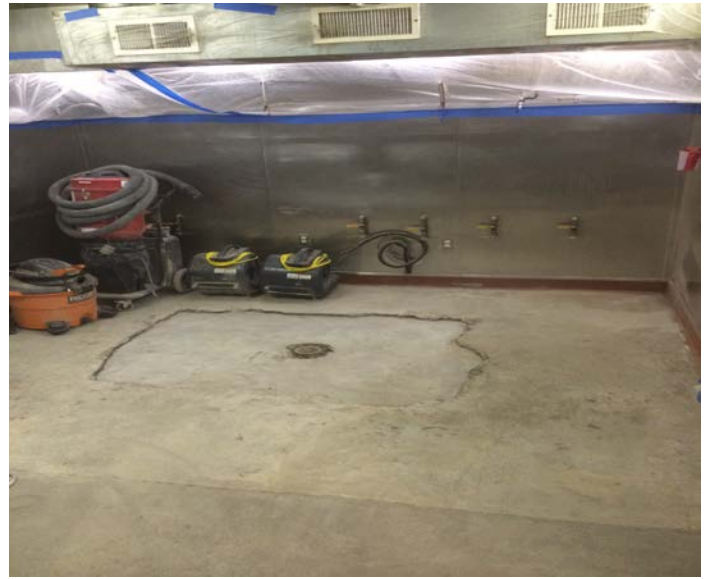
Heavily damage areas pre patched with polymer concrete

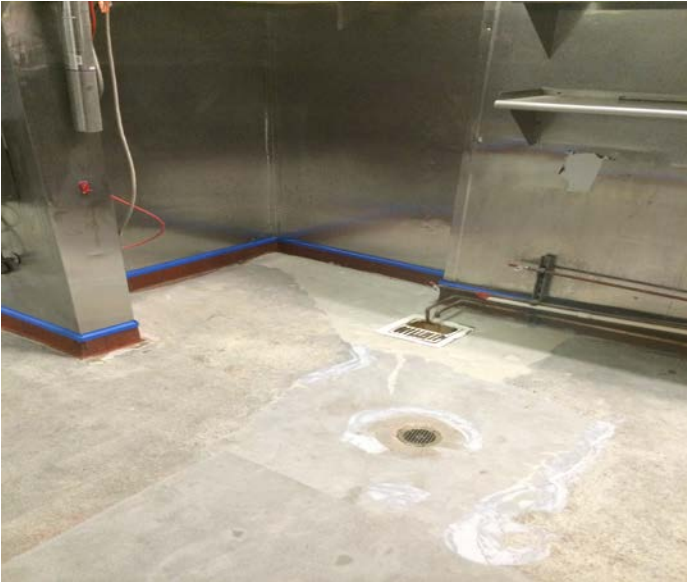
Seams and joints pre-filled as well, cove base primed

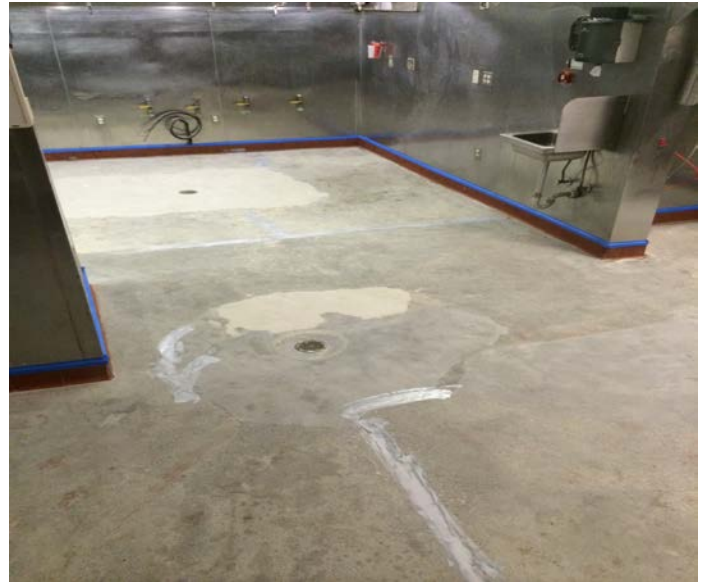
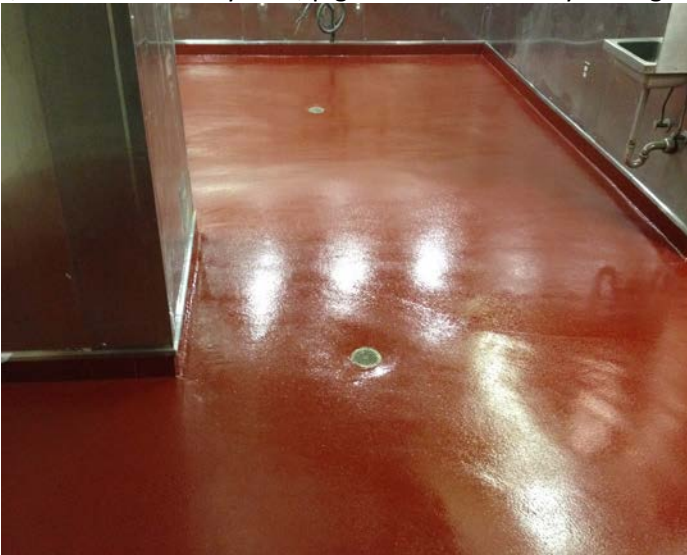
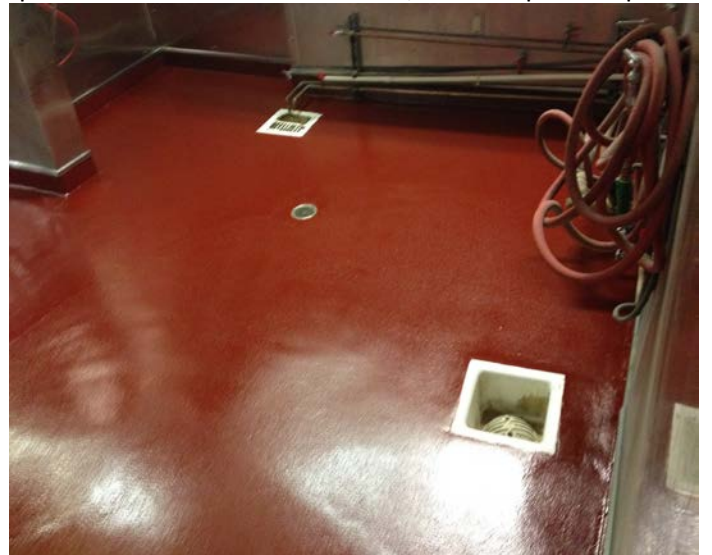
1/4" trowel down system, pigmented all the way through with slope to drains & 100% solids USDA/FDA compliant topcoat
