# -Commex Corporation, Hayward, November 2016-

Polymer Floor & Wall Coating Systems

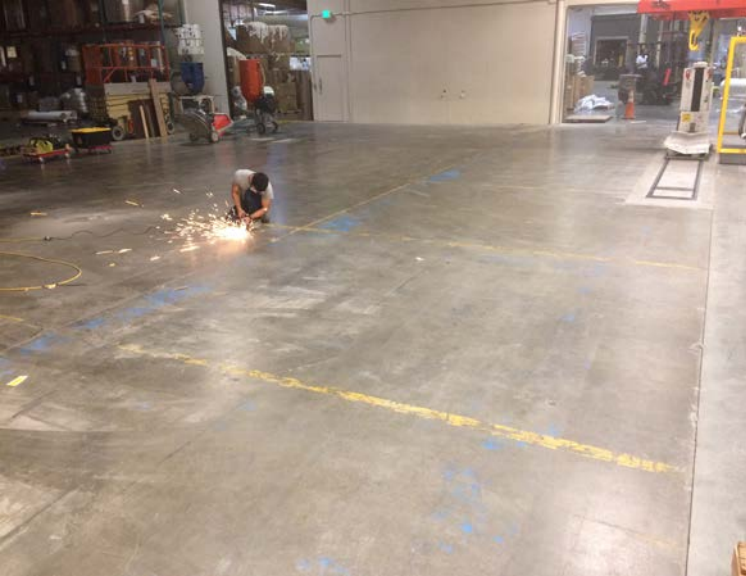
Substrate of hard concrete with anchor bolts, deep scratches, overlays and other imperfections from years of heavy use

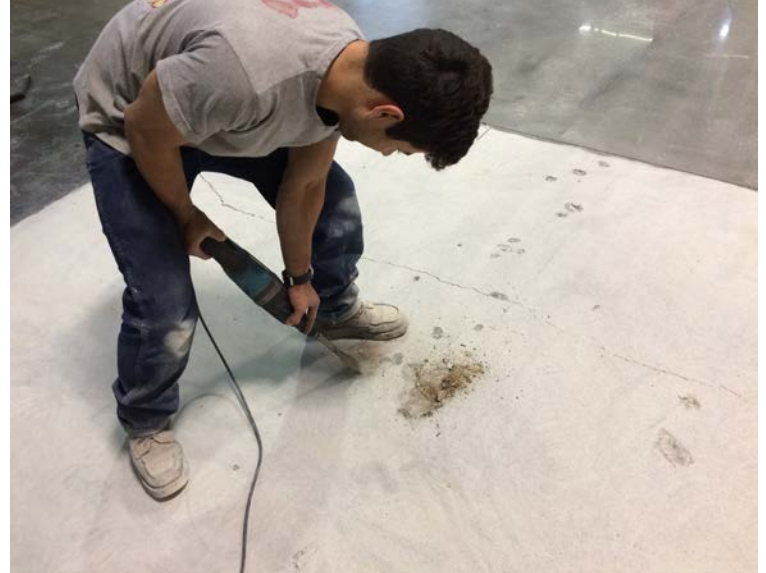
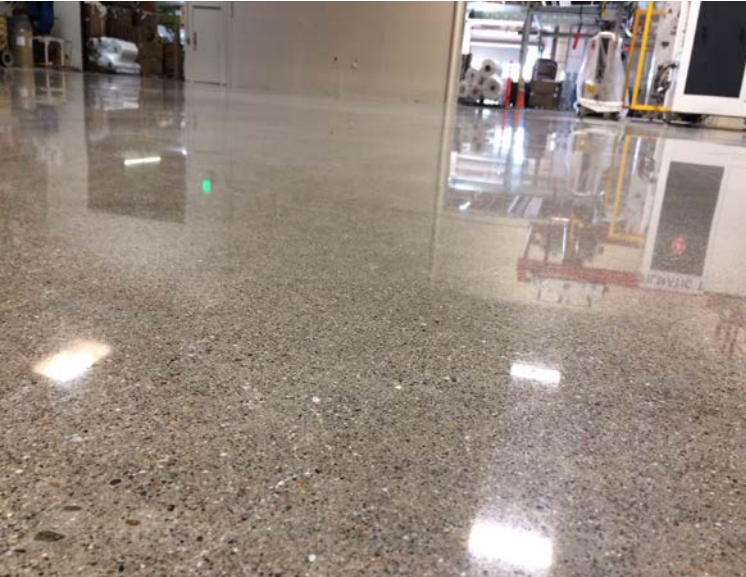
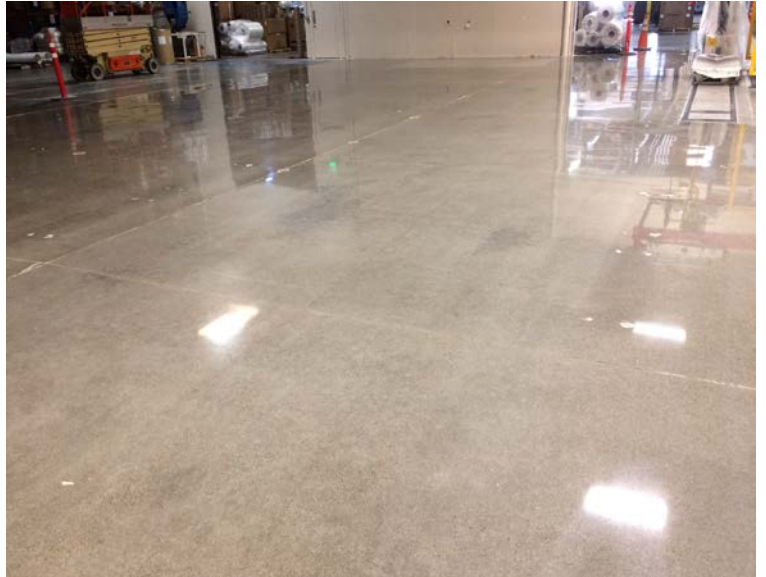
Nice aggregate exposure & high gloss after 8 steps of grinding & polishing, densifying, sealer application & high speed burnishing
