# -Le Duc Catering (dish wash area), Emeryville, December 2015-

**- Impact Floor Solutions, Inc. -**  
Polymer Floor & Wall Coating Systems

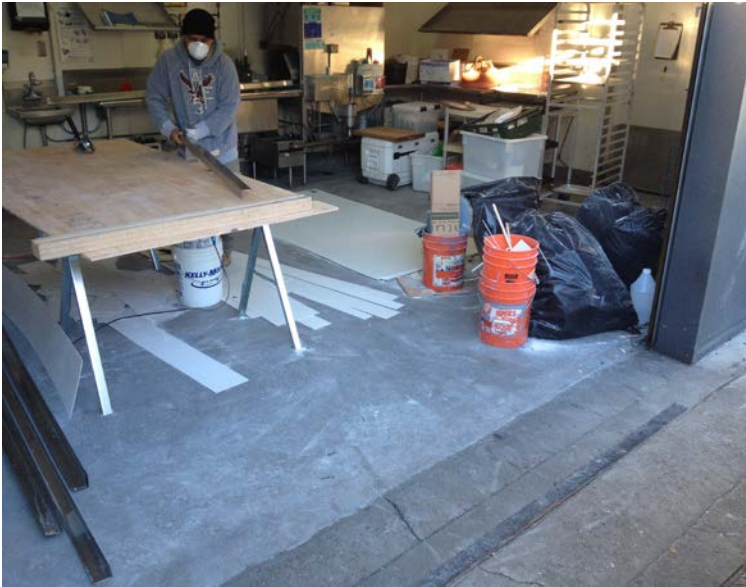
Thin epoxy coating completely worn out to exposed substrate Various repairs made over the years & all non-skid texture gone
