-Le Duc Catering (walk-in coolers), Emeryville, December 2015-

- Impact Floor Solutions, Inc. -

Polymer Floor & Wall Coating Systems

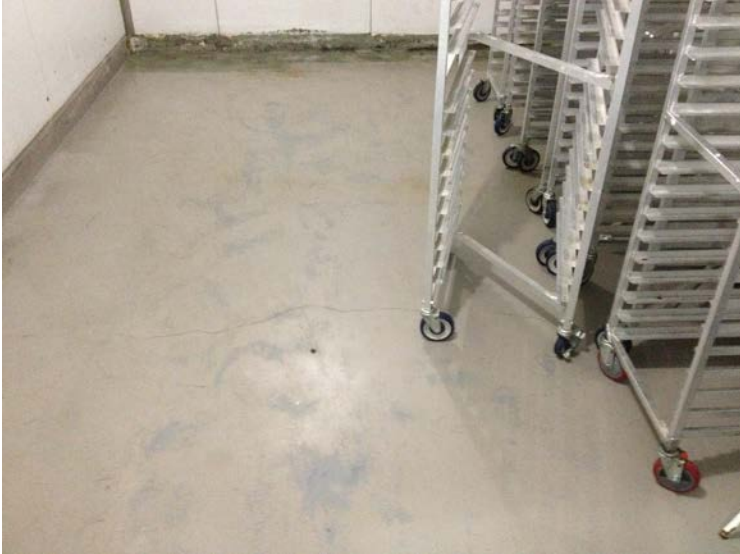
Years of intensive use have worn out topcoat

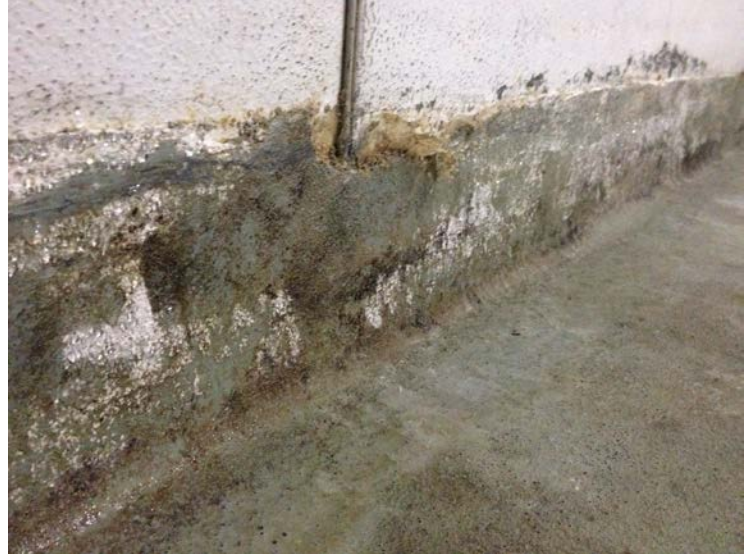
Moisture and cove against metal sandwich panels made it fail

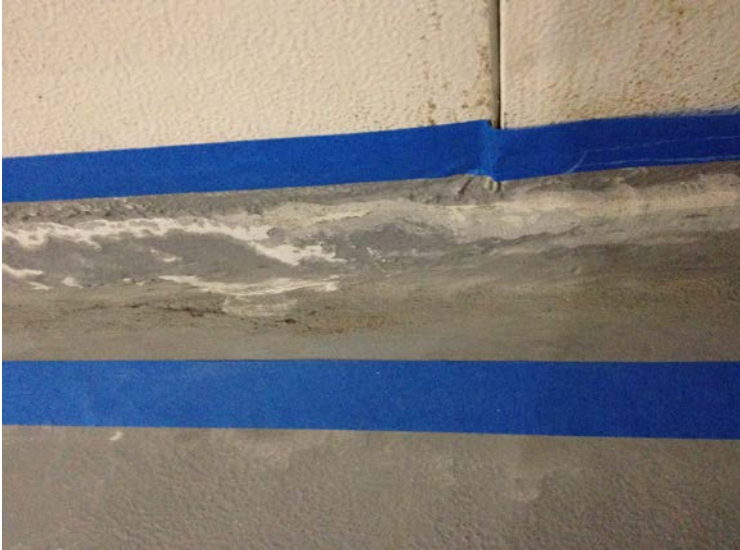
Cove base grinded down shows moisture from underneath

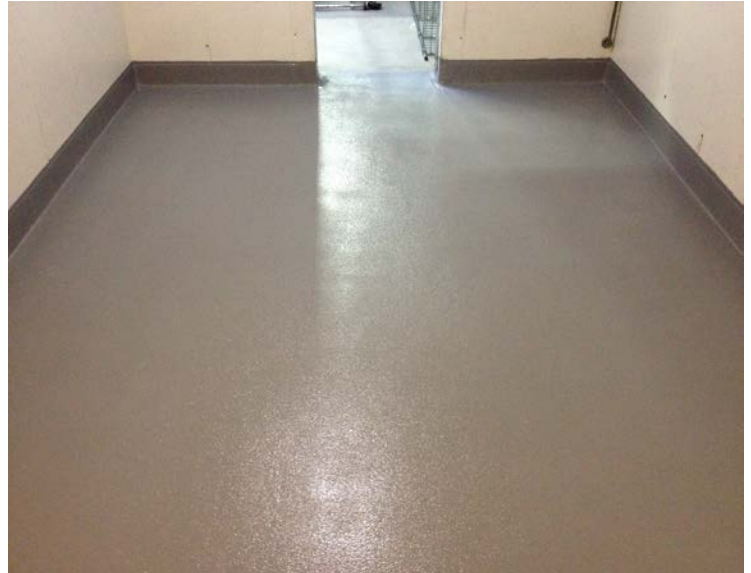
Good for another long time of intensive use
