-Le Duc Catering (wash down area), Emeryville, December 2015-

- Impact Floor Solutions, Inc. -
Polymer Floor & Wall Coating Systems

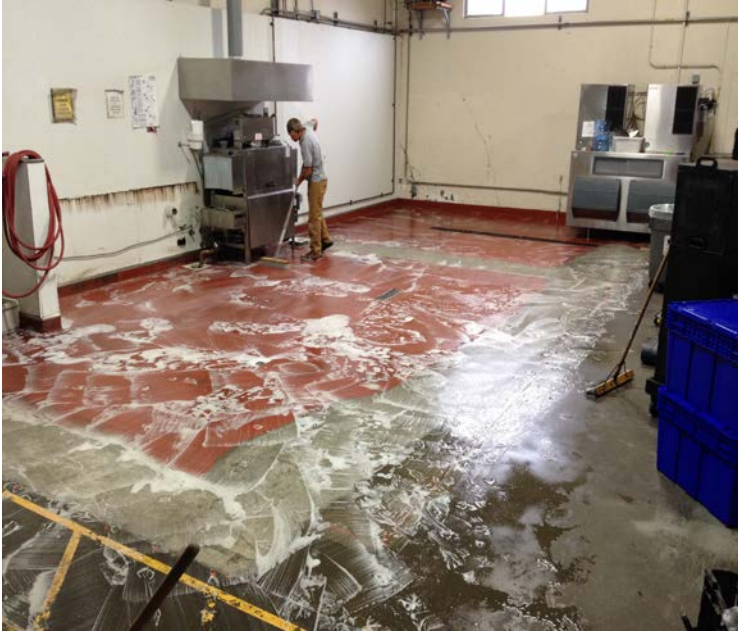
First removal of food grease with Microbial cleaner & hot water

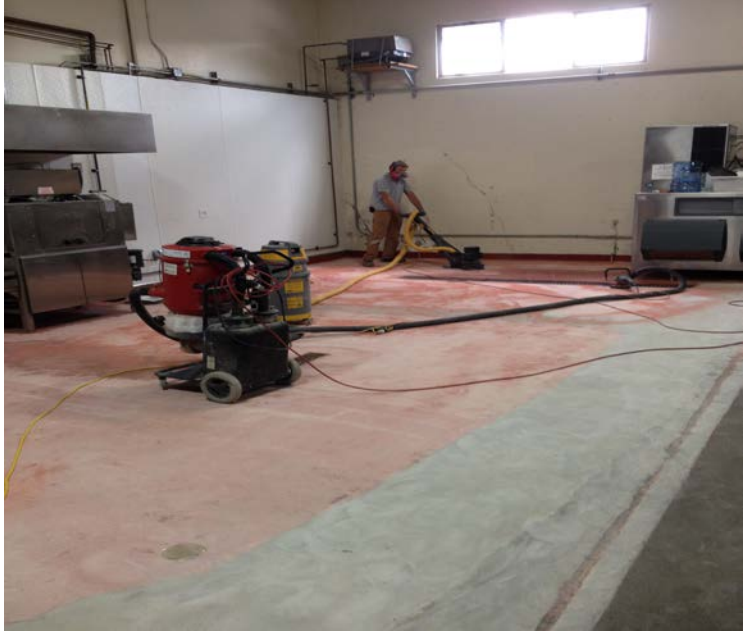
Diamond grind with aggressive diamonds & HEPA dust collection

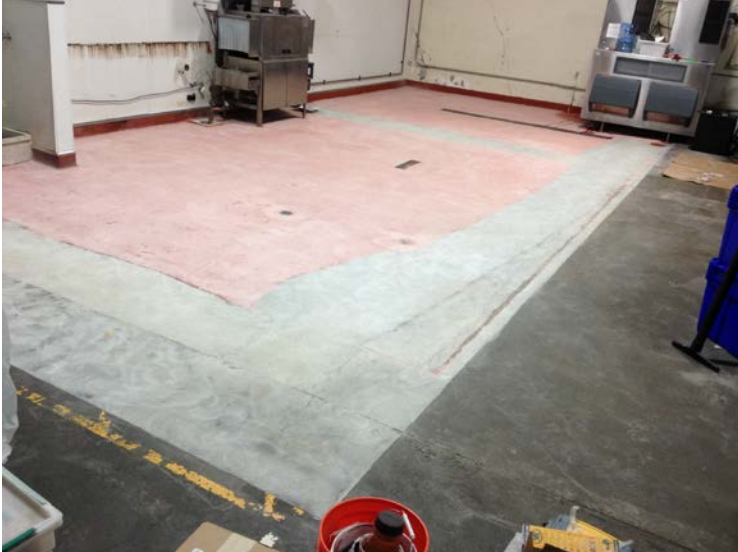
Area degreased, mechanically prepared & saw cut at ends

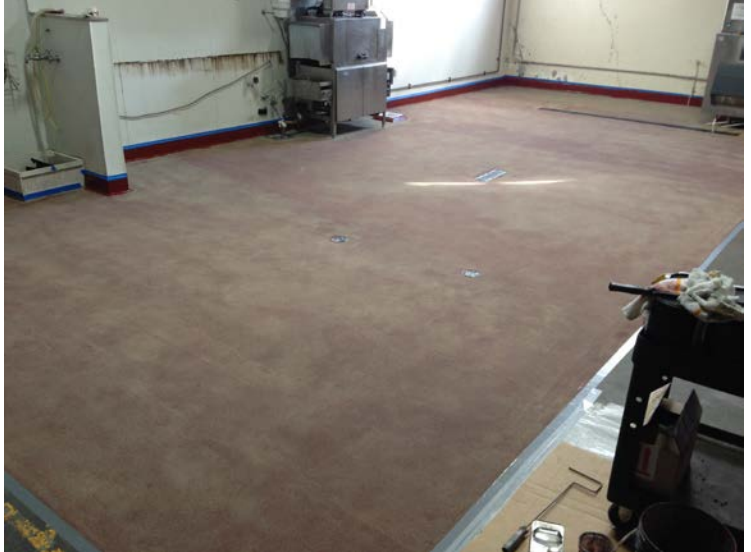
First application of cementitious urethane for superior bonding

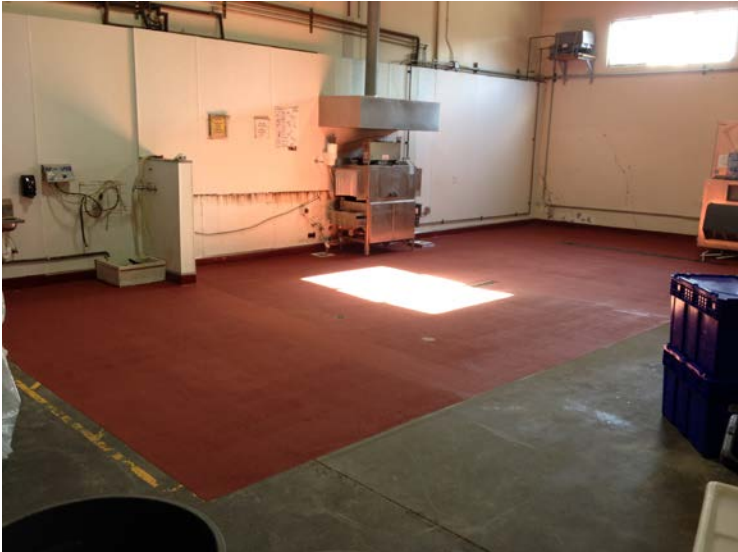
Three part cementitious urethane topcoat system for durability

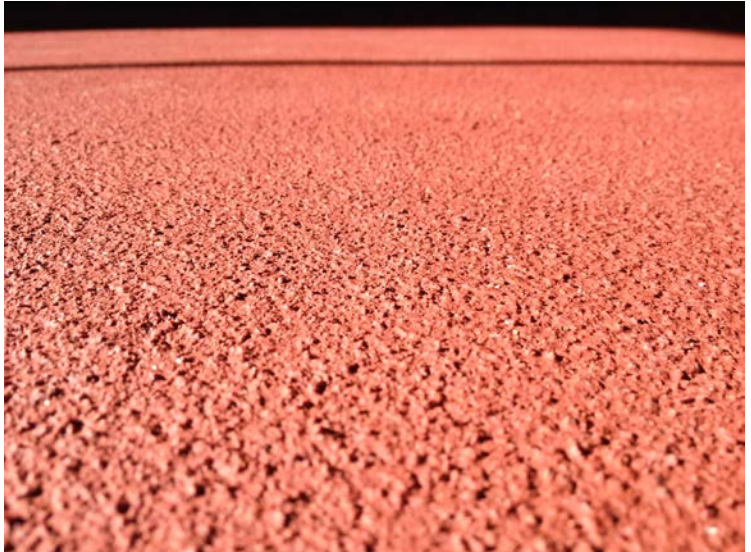
Aggressive non-skid profile makes this wash area slip resistant
