# -Undisclosed Restaurant, San Francisco, March 2016-

**- Impact Floor Solutions, Inc.-**

Polymer Floor & Wall Coating Systems

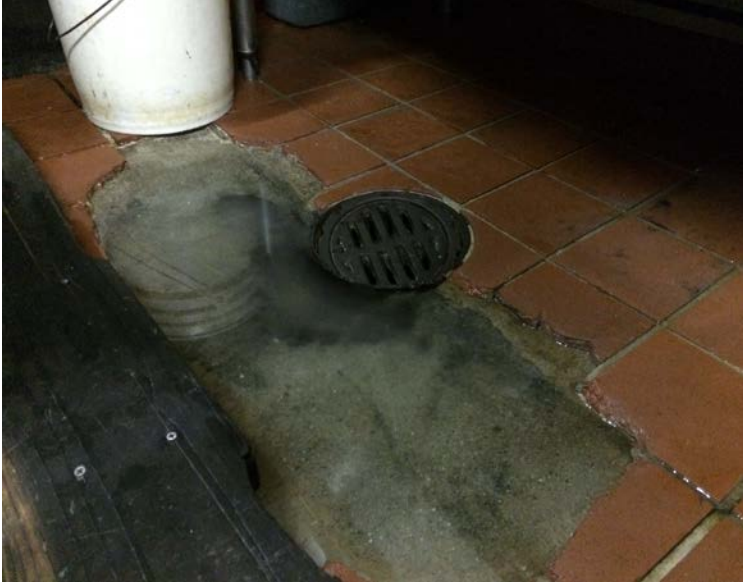
Quarry tile completely gone which caused saturated substrate

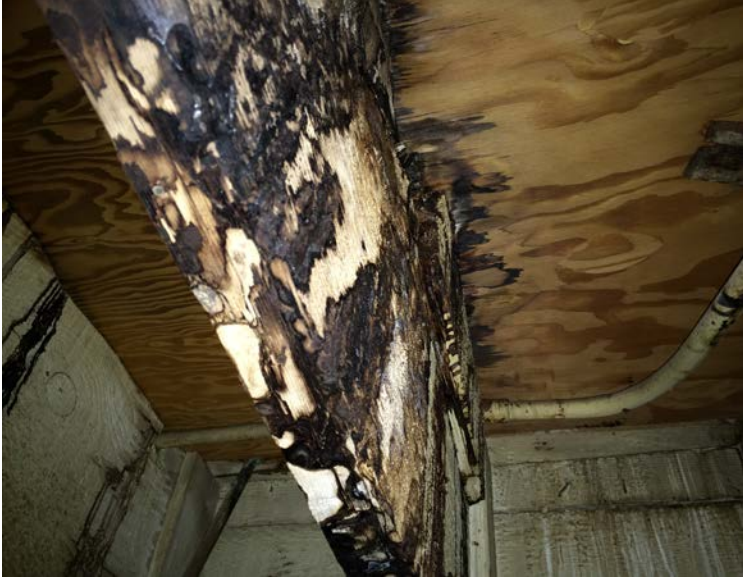
Subfloor and joist heavily damaged

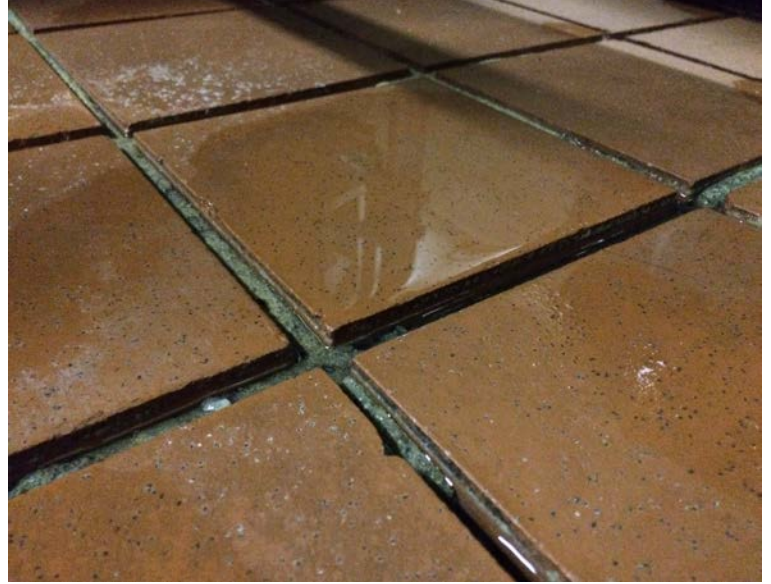
Grout washed out after years of intensive use & cleaning

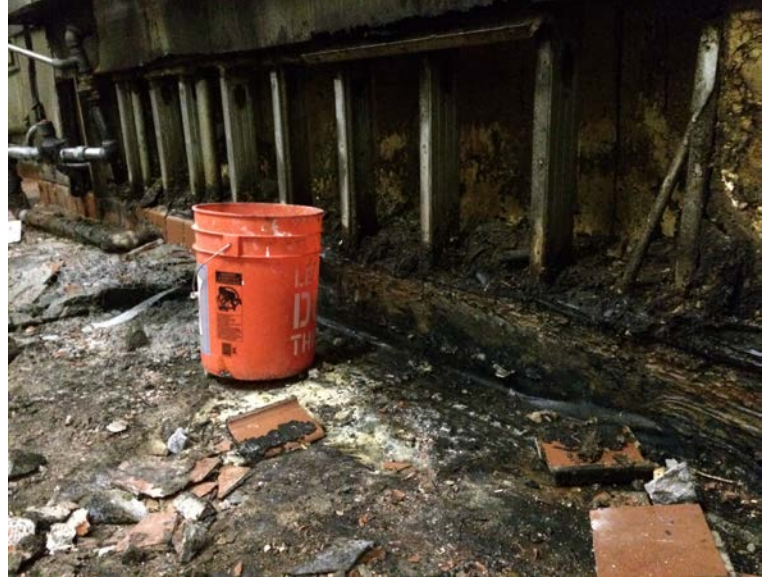
After tile removal found more damage than hoped for...
