-Zachary's Pizza, January 2017-

- Impact Floor Solutions, Inc.-

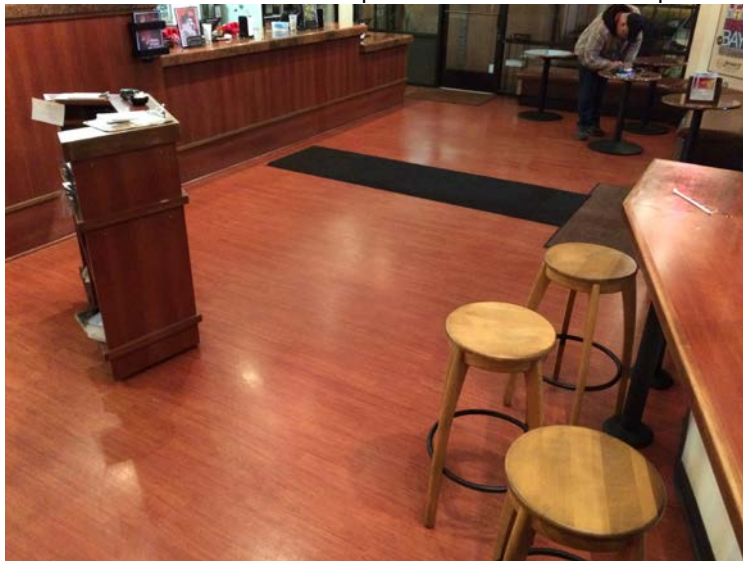
Dated interior needs remodel to provide better customer experience

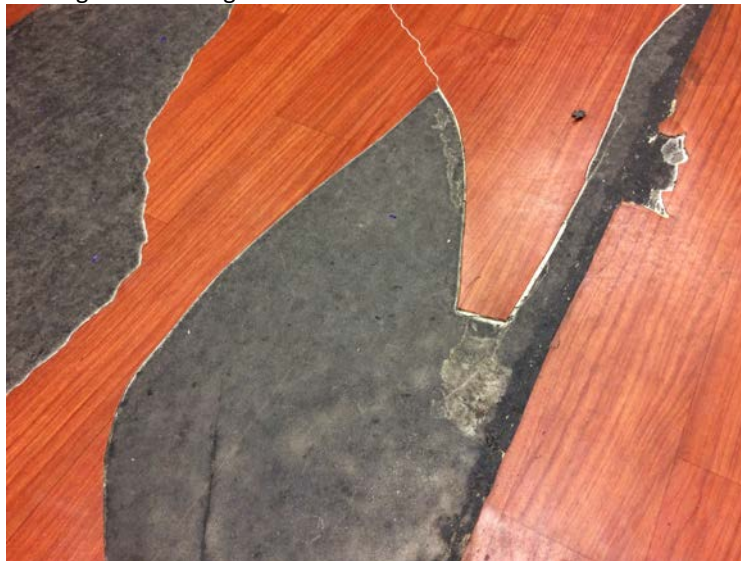
Existing floors damaged & adhered to concrete with mastic adhesive
