# -Yet Sun Market, Oakland, September 2015-

## - Impact Floor Solutions, Inc. -

Polymer Floor & Wall Coating Systems

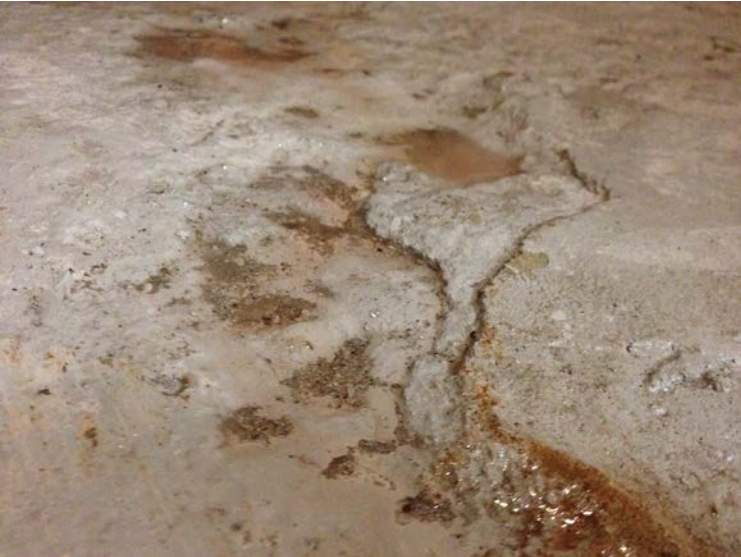
Encountered terrible substrate conditions and animal grease

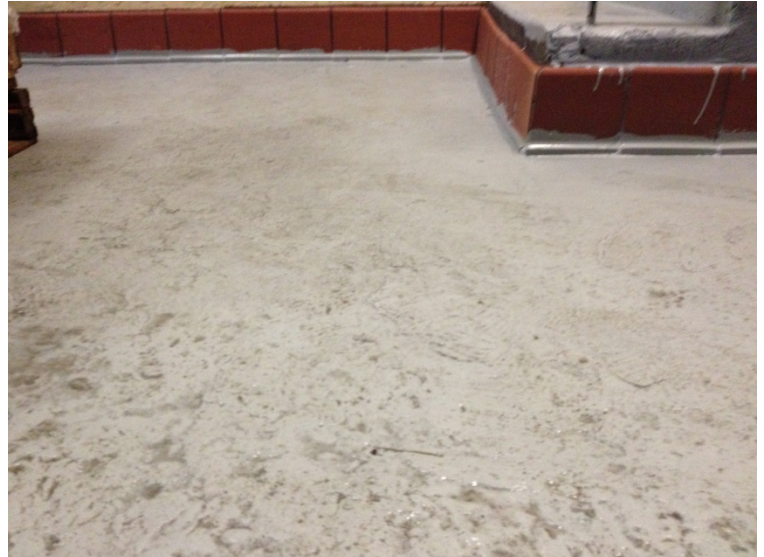
Concrete paint was applied by others, no surface preparation done
